MEMORANDUM

EUGENE WATER & ELECTRIC BOARD

TO: Commissioners Helgeson, Brown, Mital, Simpson and Carlson
FROM: Mike McCann, Interim Chief Energy Officer, and Mark Zinniker, Generation Engineering Supervisor
DATE: October 27, 2017
SUBJECT: EWEB Power Canal Seepage
OBJECTIVE: Summarize EWEB's Seepage Management Approach for the Hydro Power Canals

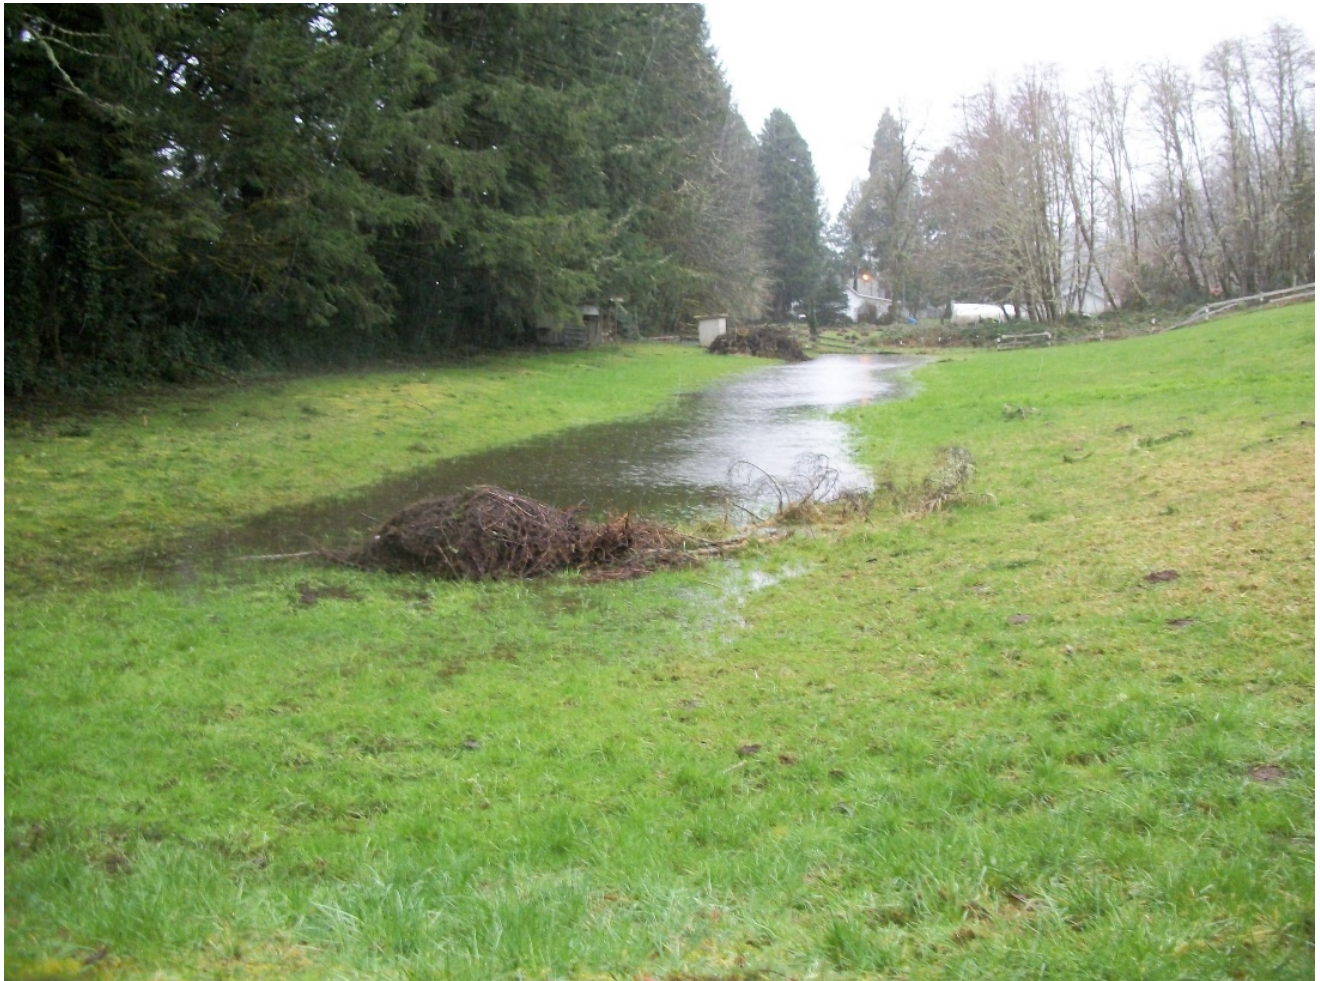
Neighboring properties with poor drainage tend to be the most sensitive to canal seepage. Examples include properties sandwiched between the power canals and Highway 126. The highway itself is constructed on a raised embankment that impedes the downhill flow of water (canal seepage as well as stormwater). The water must either find its way to a culvert passing beneath the highway or infiltrate into the ground. Figure 1 shows this type of property during the wet weather season after a period of heavy rainfall. The highway is just beyond the trees on the left side of the photo and canal slope on the right.

Figure 1. Ponding between the Leaburg Canal and Highway 126 following heavy rainfall

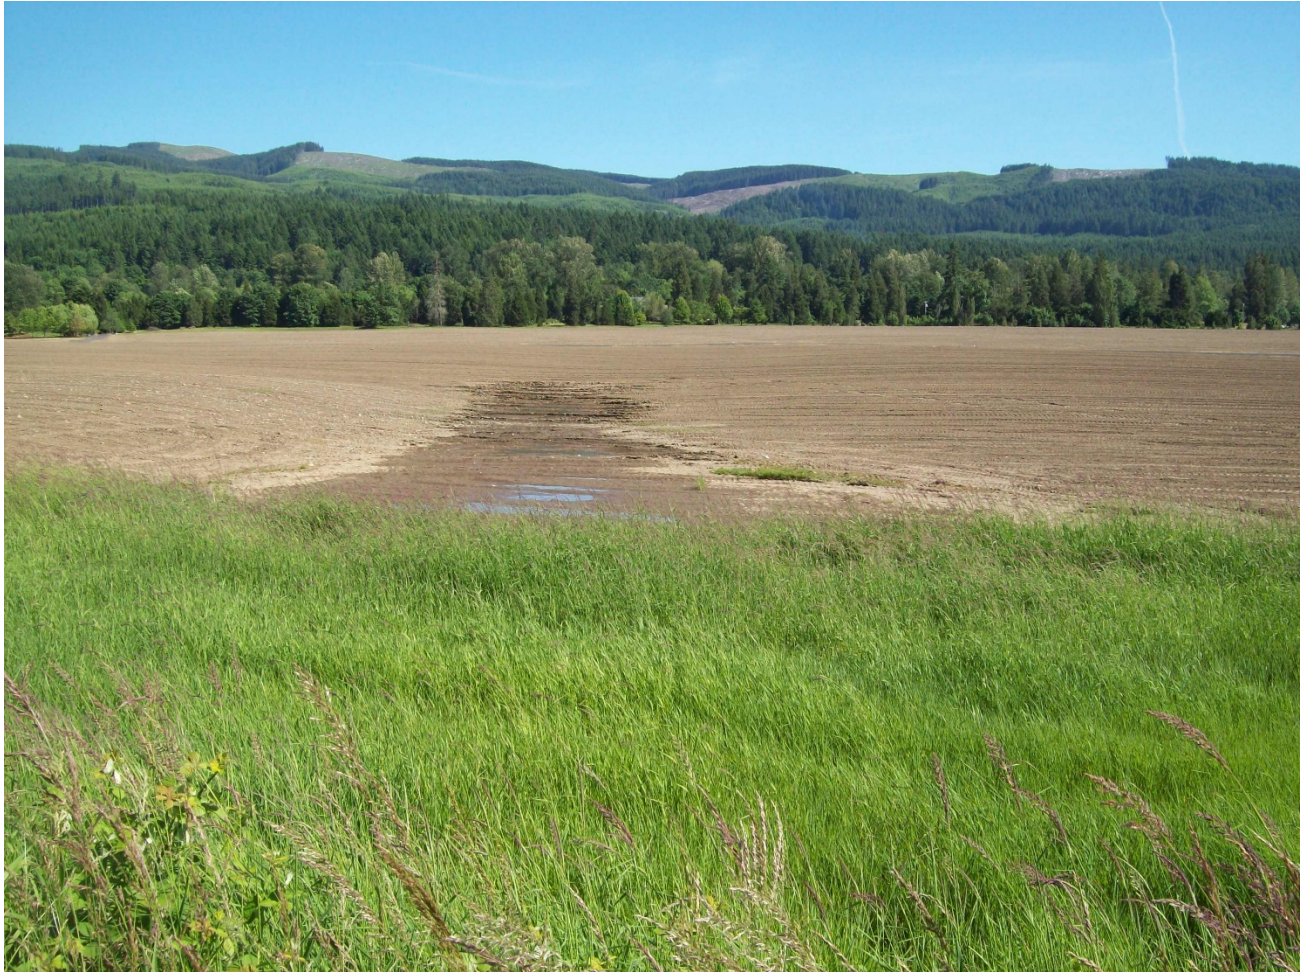
Other properties adjacent to the canals are relatively flat. An example of this type of property is shown in Figure 2. Even though not sandwiched between the canal and highway, the water must pond significantly before it can drain away, otherwise it must infiltrate into the groundwater table. Again, this type of ponding is typically only present during periods of heavy rainfall.

Figure 2. Seepage effects on flat farmland adjacent to the Walterville Canal

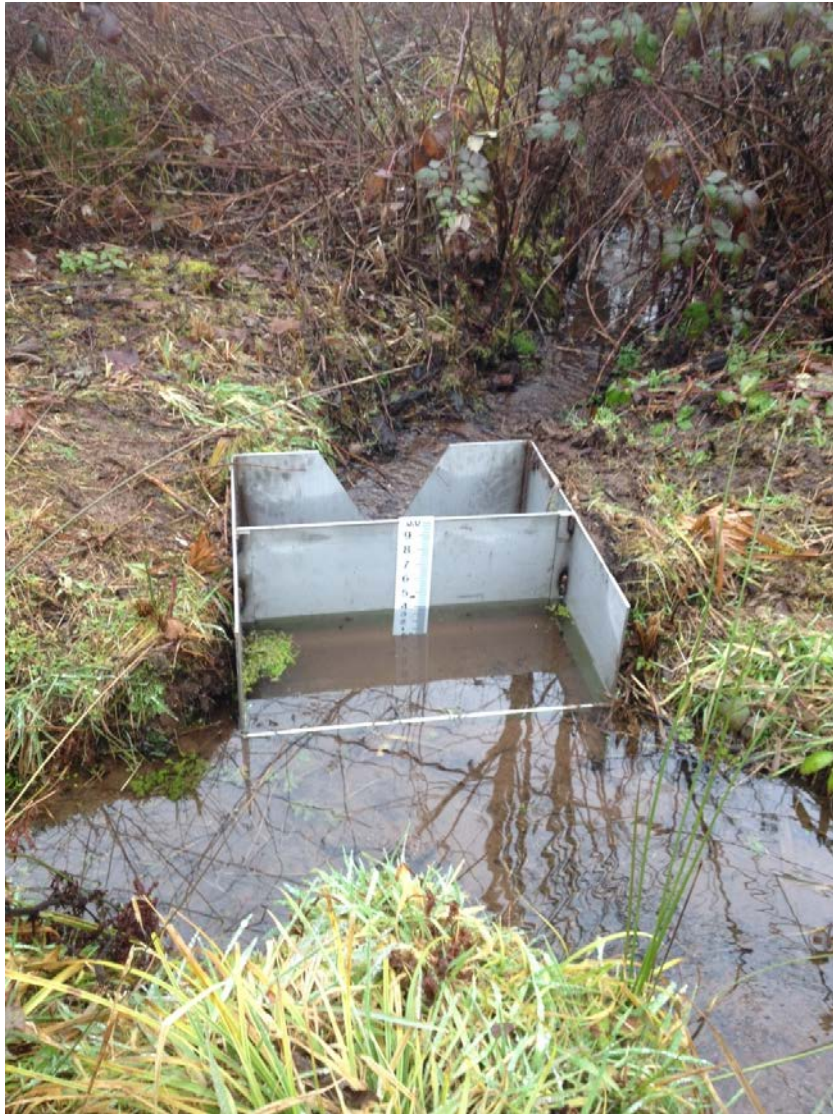
Figure 3. Permanent seepage weir monitoring station

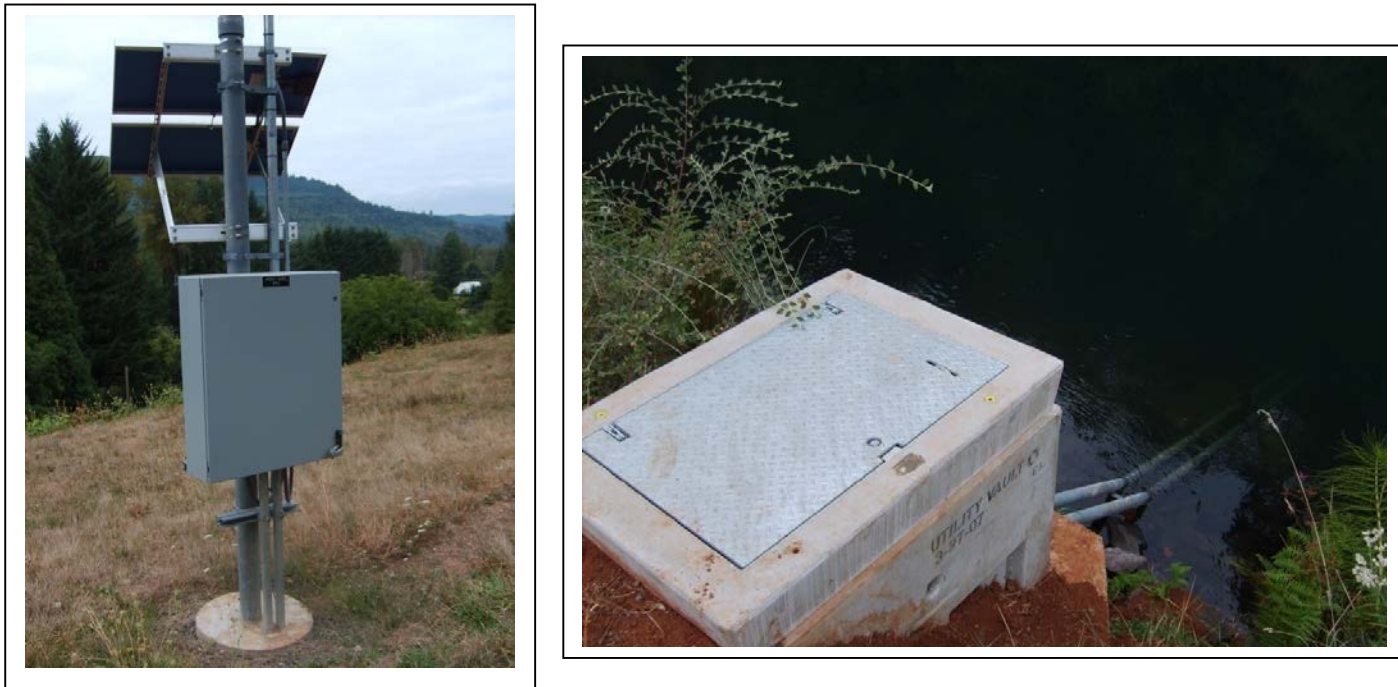
Figure 4. HMCS water level monitoring station, Leaburg Canal

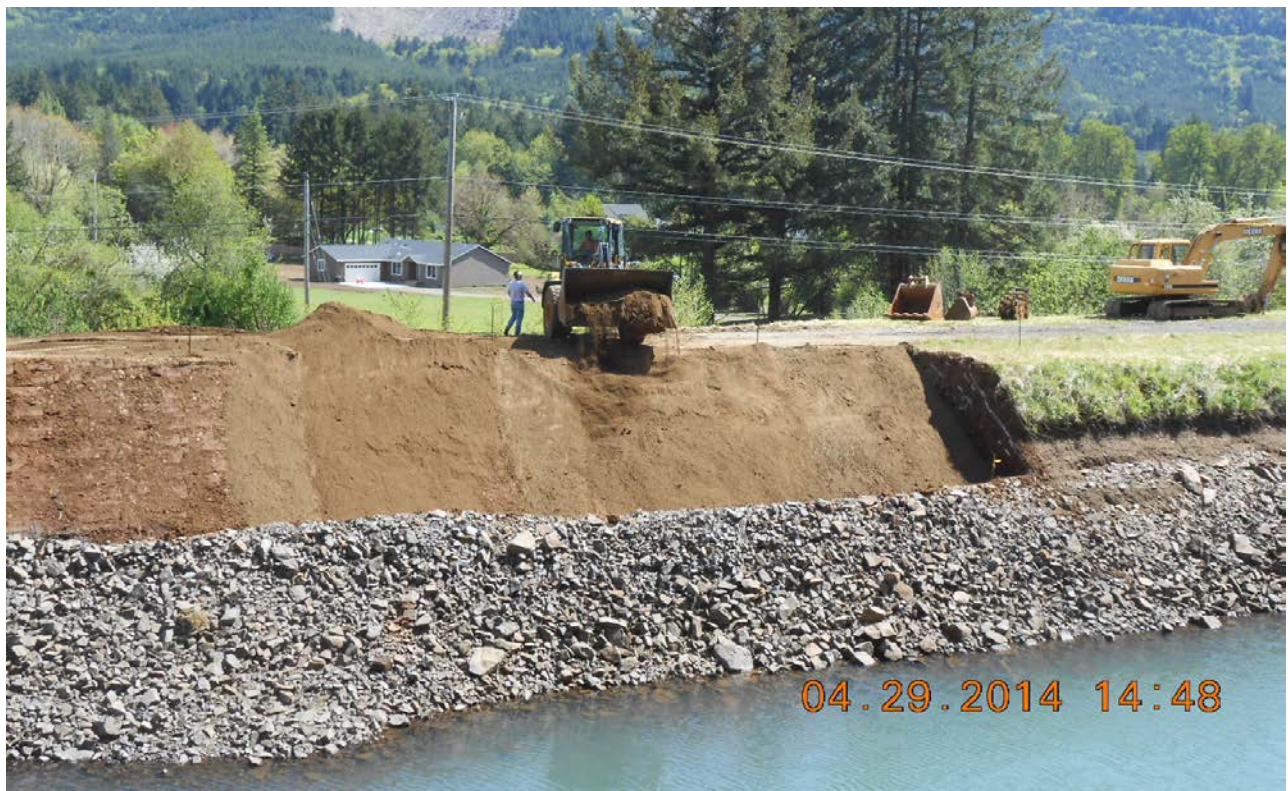
Figure 4. Shallow canal slope repairs, Leaburg Canal 2014

The effectiveness of canal repairs completed to date, in terms of reduction in seepage, has been variable. While the 2015 and 2016 repairs were highly effective at reducing seepage, the effectiveness of the 2014 and 2017 canal repairs was marginal. This variability is indicative of the

The linear footage of canal bank that can be improved in a given year is dependent on how much of the interior slope of the canal is targeted for repair. If monitoring data indicate that the seepage is originating in the upper portion of the embankment and a relatively shallow repair design is expected to suffice, the linear footage of repair will be greater than if monitoring data indicates that the seepage is sourced deep on the canal and coffer damming will be required to complete the repairs. Figure 4 shows relatively shallow repair work underway in 2014 and Figure 5 shows a deep repair in progress with a hydraulic cofferdam system.

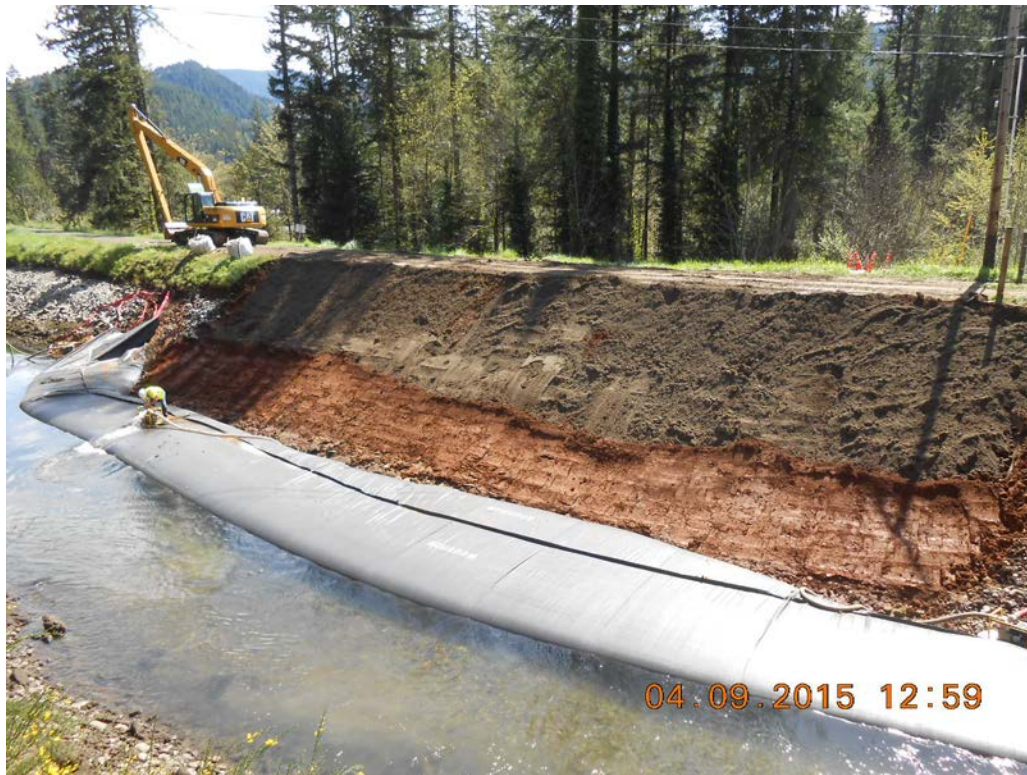
Figure 5. Deep canal slope repairs with coffer dam, Leaburg Canal 2015
