Aug 26, 2019
UPDATE: Sep 09, 2020

City of Eugene
Eugene, Oregon

RE: EWEB 40th Ave, Arborist Report

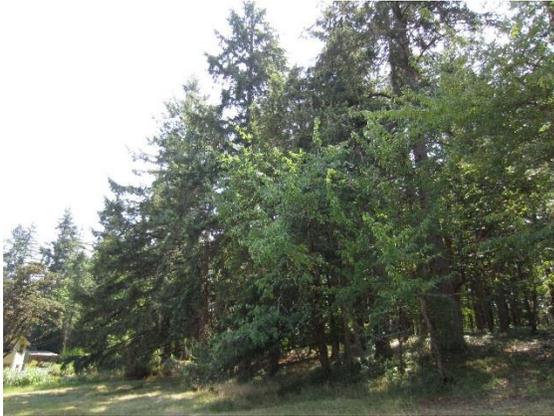
Douglas Fir Woodland

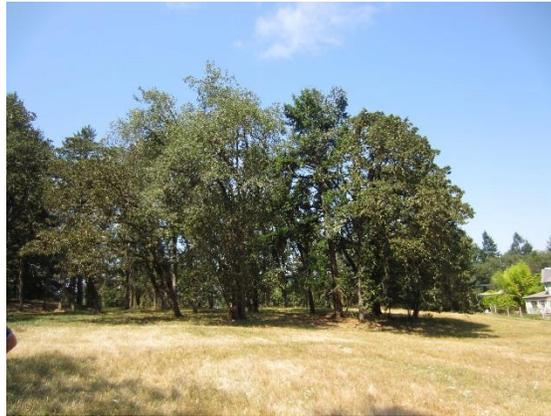
Oak Woodland

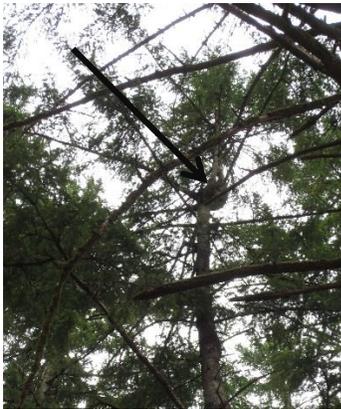
Co-dominant leaders

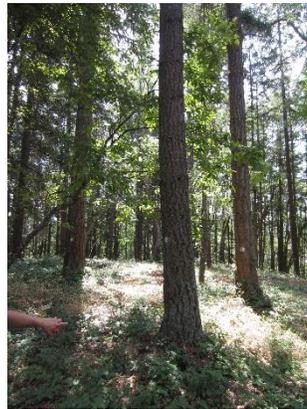
Open understory: bramble

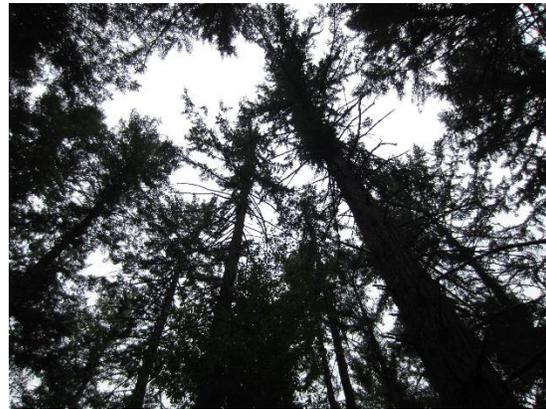
Canopies: some opening & some overcrowding

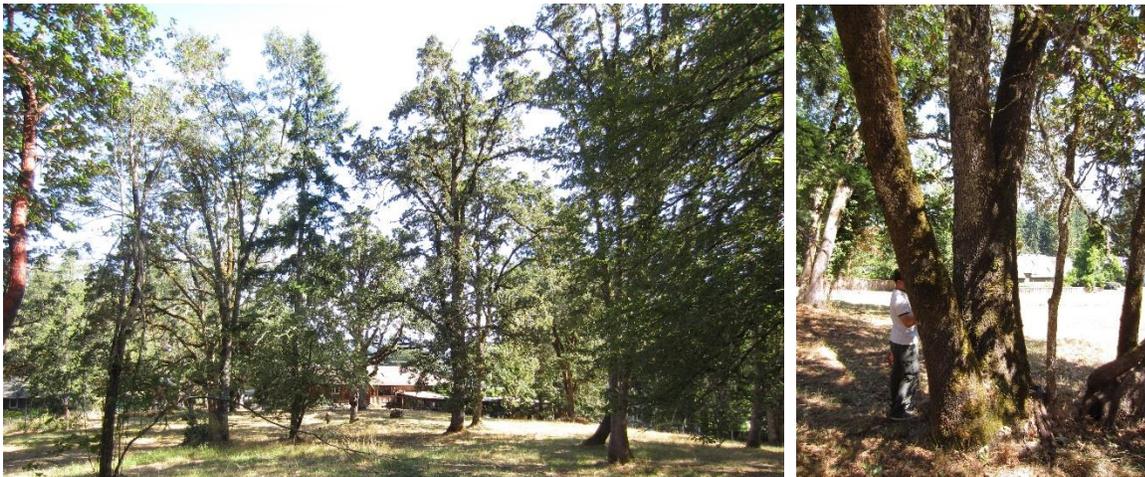
Oak woodland with grass understory

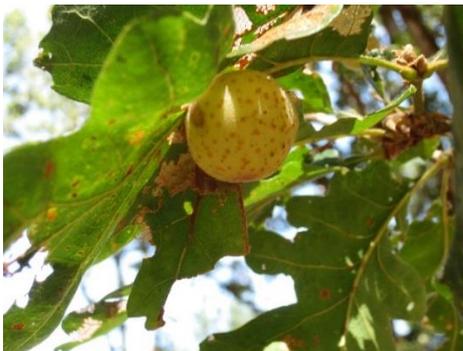
The majority of the oaks had skeletonized leaves which is indicative of pests. As the trees are more mature, the trees did not seem to be significantly affected by the pest damage. In addition, the majority of the Oaks had galls caused by oak apple gall wasps. Galls usually occur on leaves and stems, but also may occur on flowers, fruits, twigs, branches, trunks, and roots. Gall-making insects are generally not considered pests as they do not damage the oak tree host but may cause earlier defoliation. Although there are some insecticides registered for use against gall-making insects, their use is generally unwarranted, and not recommended here. Furthermore, pesticides may kill beneficial insects that help control gall-making insects and could damage the health of the woodland’s ecosystem.

Oakleaf Galls

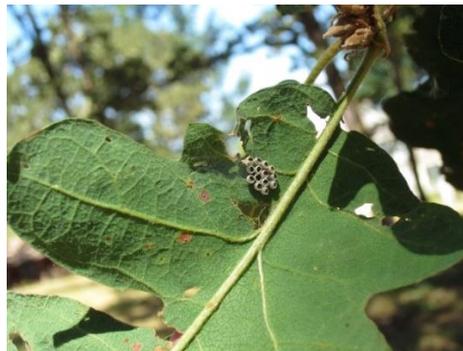
Insects

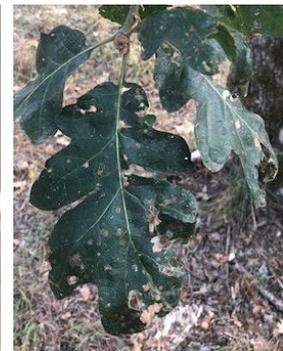
Skeletonized leaves

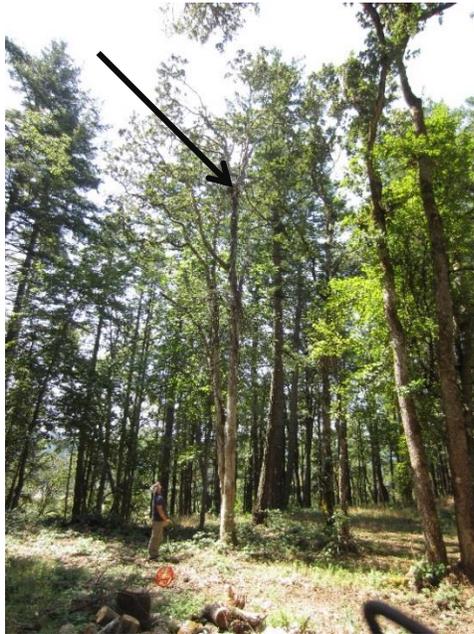
Possible Nest in Oak

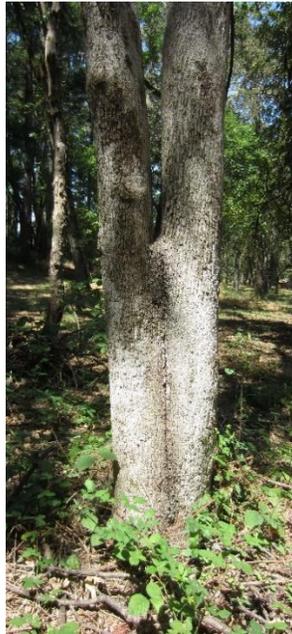
Inosculation

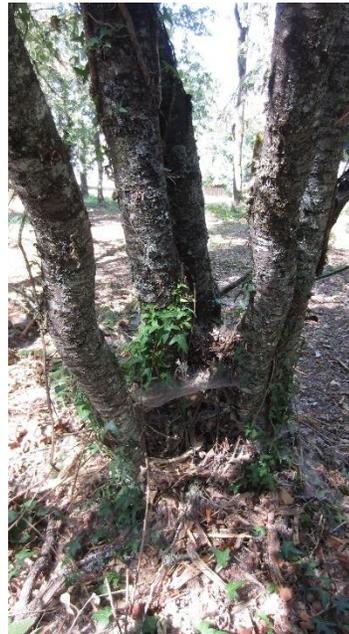
English Ivy beginning to climb

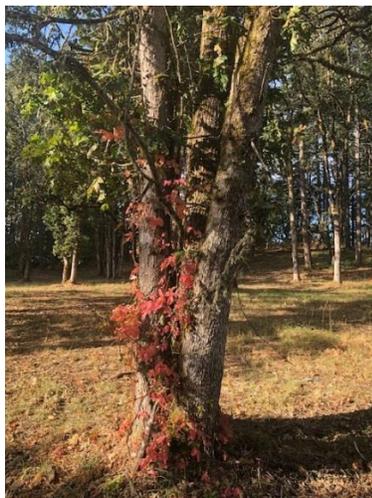
Poison Oak vines climbing trunk

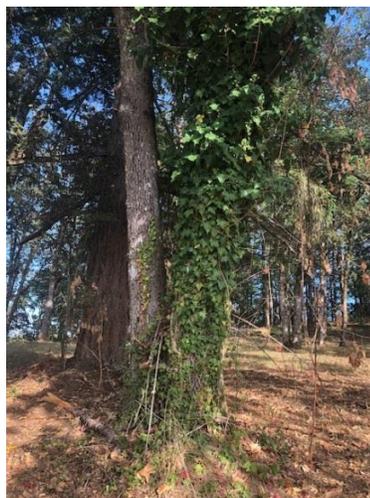
English Ivy climbing trunk

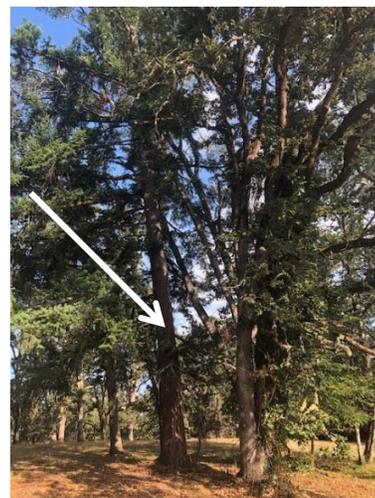
Fir outcompeting Oaks
