Consulting Structural Engineers Portland, Oregon • Tacoma, Washington

Re: College Hill 607 Reservoir Evaluation

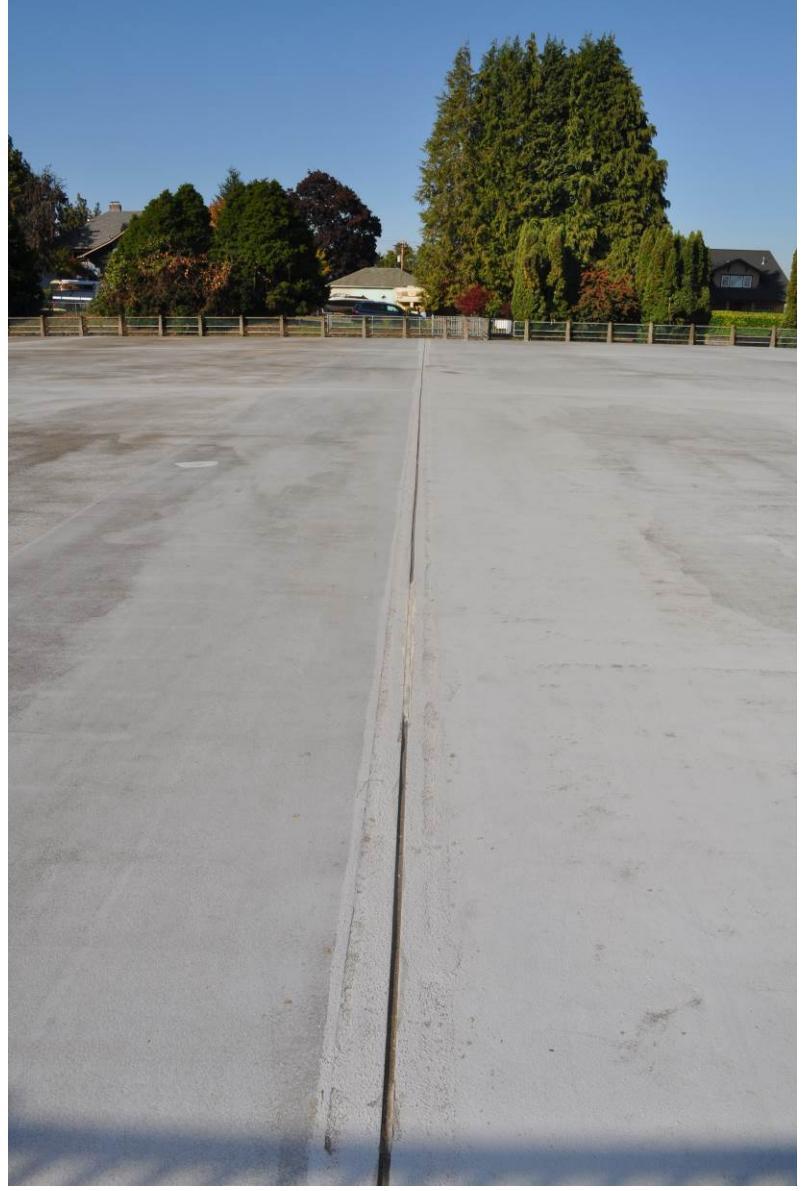
While investigating the roof slab we observed several locations where the flexible mastic at the expansion joints had pulled away from the concrete, presumably due to thermal expansion and contraction of the adjacent roof slab panels. This mastic is part of a waterstop

Figure 4: Roof Slab Expansion Joint Showing Spot Repairs to Failing Mastic

In addition to providing a functional LFRS the reservoir is in need of repairs and maintenance. The spalling and cracks along the exterior walls of the reservoir should be repaired to halt any further deterioration. The waterstop system at the expansion joints between the roof panels also appears inadequate and needs to be replaced. Two options were considered:

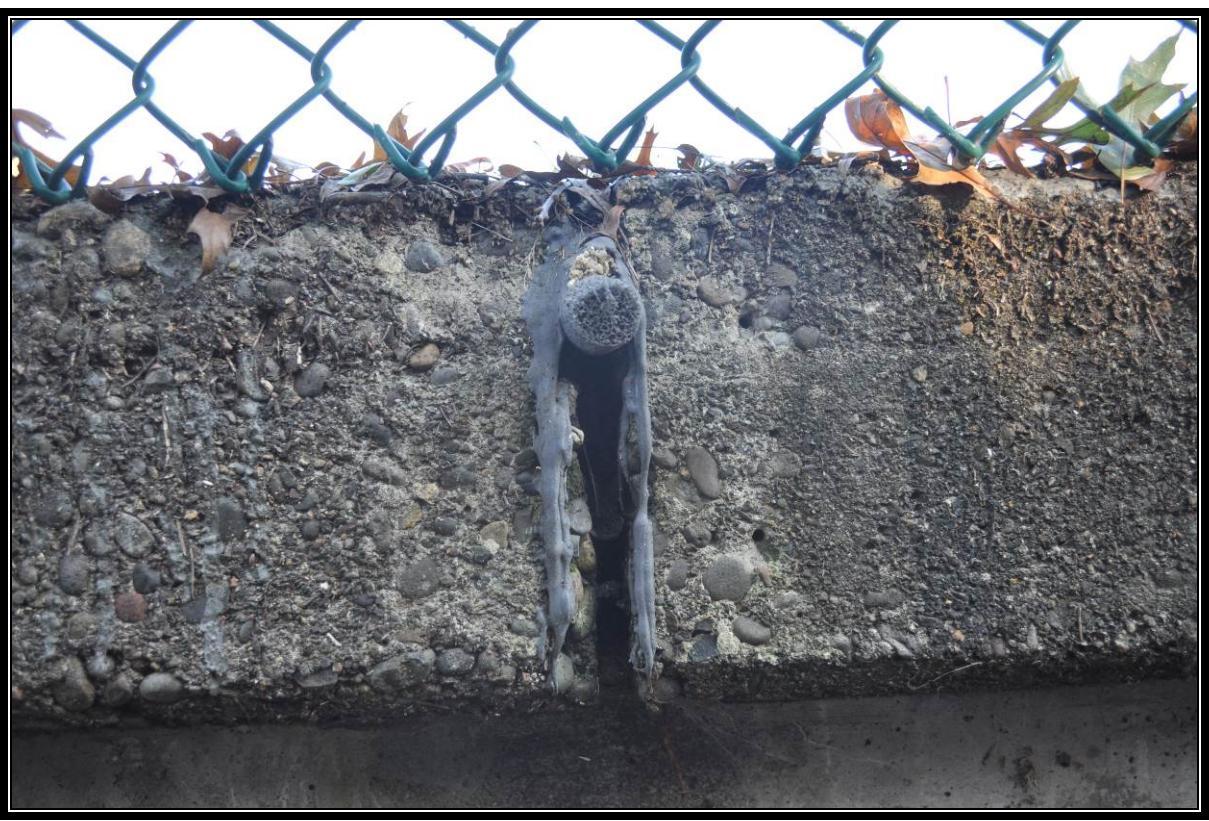
system which was installed to replace the original copper-strip waterstop system. The new waterstop system consists of backer rod with a flexible mastic coating. This new system was observed to have failed in several locations and EWEB continues to spot repair this system as required with varying results (see Appendix Figure 4). We observed several locations where the vertical exposure of the expansion joint was not watertight. It appears that water can penetrate directly underneath the backer rod at these locations (see Appendix Figures 5 and 6).

Figure 5: Non-Watertight Expansion Joint in Roof Slab Perimeter

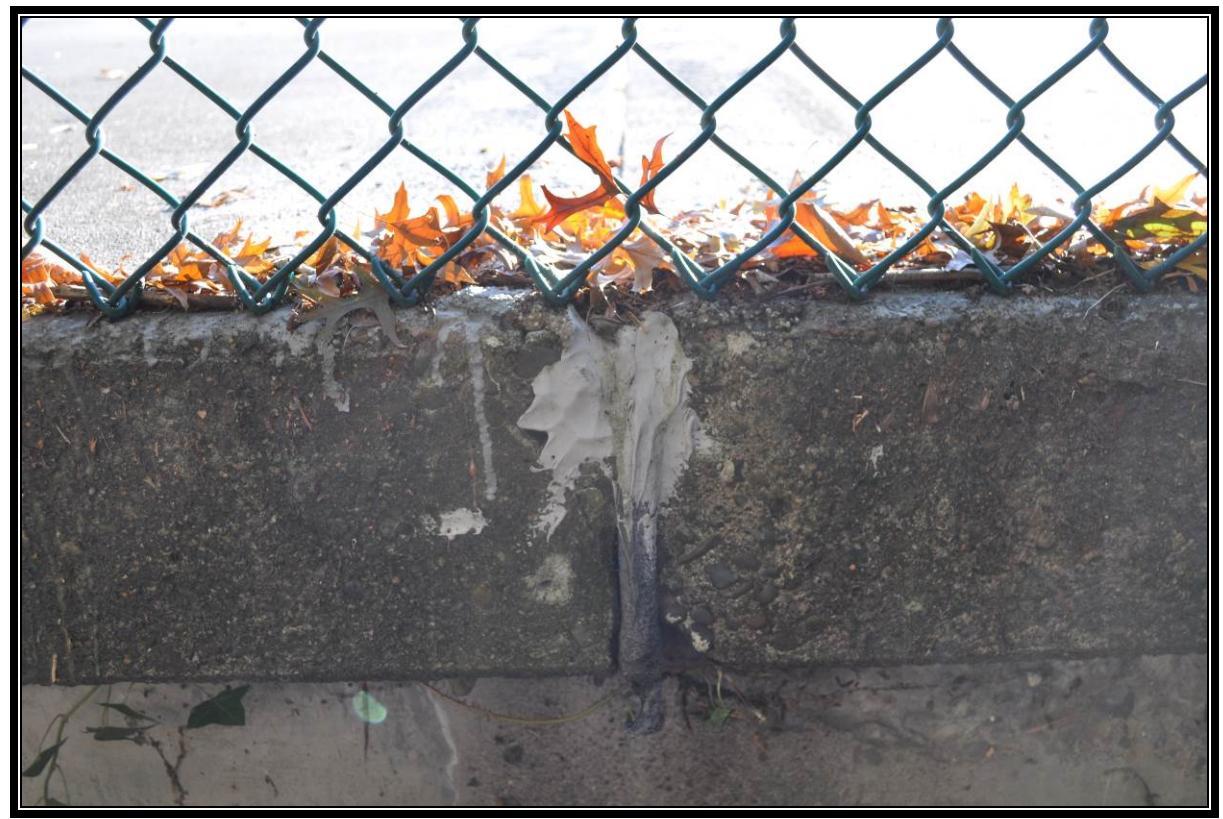
Figure 6: Non-Watertight Expansion Joint in Roof Slab Perimeter

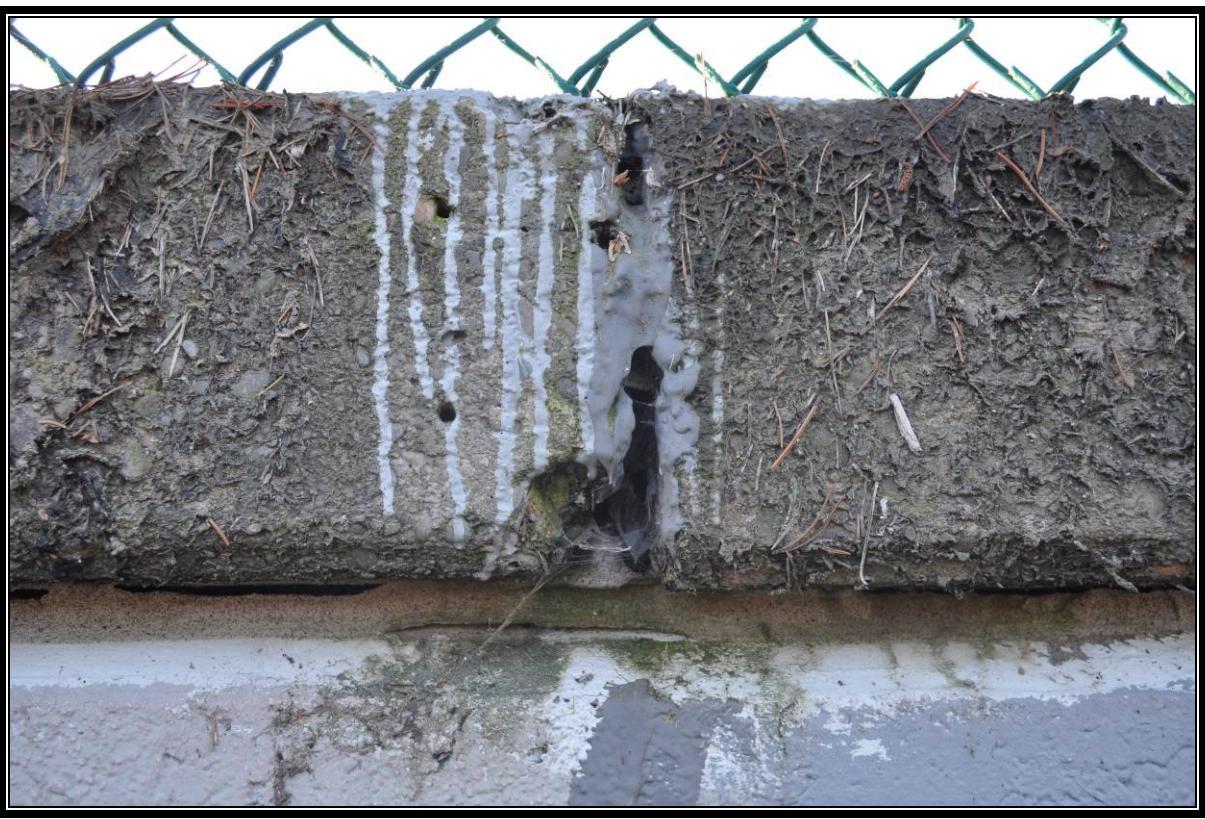
EWEB also previously replaced the water-stop system around the perimeter of the reservoir between the underside of the roof slab and the top of the walls with an application of flexible mastic. At several locations we observed that mastic pulling away from concrete and daylight could be seen between the roof slab and wall interface at several locations (see Appendix Figure 7)

Figure 7: Mastic Pulling Away from Roof Slab and Wall Interface

The latter option would work well should the new interior shear wall LFRS be implemented. The waterstop system at the roof slab to wall interface also appears that it needs to be replaced by removing the existing system and replacing with a new backer rod and flexible mastic is required. If no LFRS upgrades are performed it is likely that any new caulking repairs will eventually fail due to repeated thermal cycles. The closing strips inside the tank at the floor slab, sloped floor slab, and walls also need repair and maintenance.

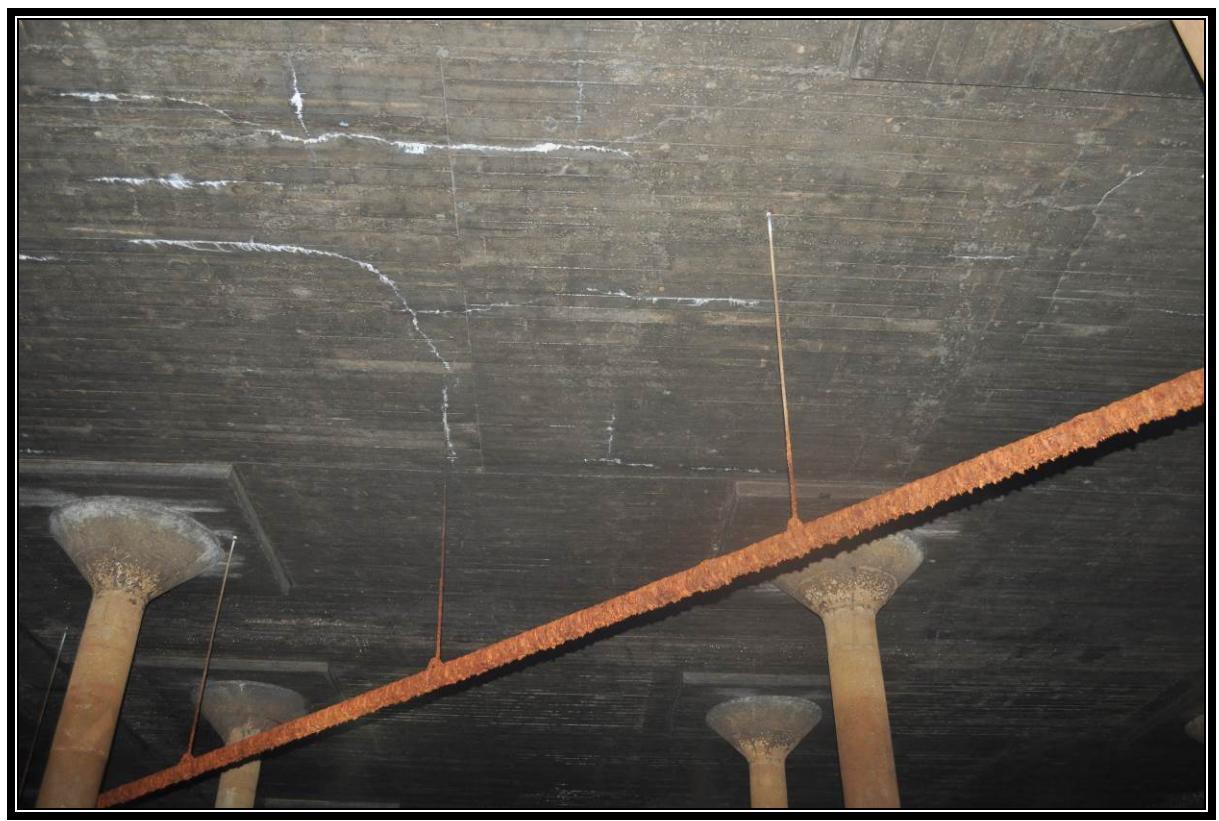
OBEC, in their evaluation report, noted many locations where the roof slab had cracked on the topside. We did not observe any cracks on the topside of the roof slab as EWEB has applied a protective coating. However, cracks were observed on the underside of the roof slab (see Appendix Figure 8). Secondary efflorescence was visible along these cracks however indications – such as no evidence of stalactite formations – suggest that these cracks are hairline, self-healed, and/or that the coating topside is halting water from penetrating through the cracks, except as noted at the roof joints.

The roof slab was analyzed with regard to the cracking that was observed on the underside during our site visit. Our analysis determined that these cracks are not due to a deficiency in strength. The determined maximum stresses inside the concrete slab are less than the calculated cracking stresses. Additionally, we did not observe any noticeable deflections corresponding to the areas of cracking, nor signs of ponding on the roof. Given the age of this concrete slab, 74 years, we assume that the cracks were either due to an untimely removal of the shoring during the construction, shrinkage cracks, and/or the result of years of repeated thermal cycles.

Figure 8: Cracks in Underside of Roof Slab

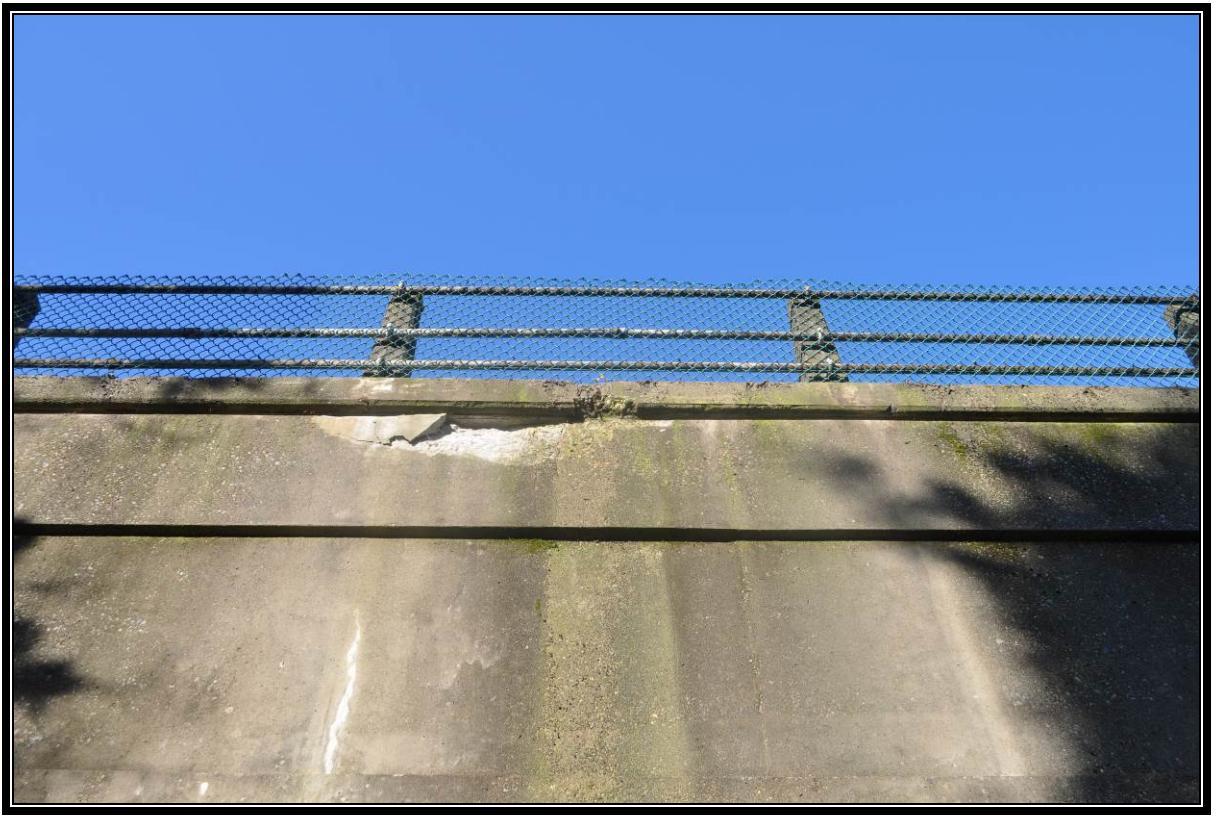
Concrete spalling and cracking was observed at several locations on the exterior wall surface (both can be seen in Appendix Figure 9). Many of these cracks appear to have self-healed over time and the spalling is not extensive relative to the overall surface area of the walls. However, at several locations, the cracks and spalling are, however, in need of repair and maintenance. Spalling was also observed at the top of the interior wall at the wall to roof slab interface. This appears likely to be occurring due to thermal expansion of the roof panels against this portion of the wall.

Figure 9: Concrete Spalling and Crack on Exterior Wall

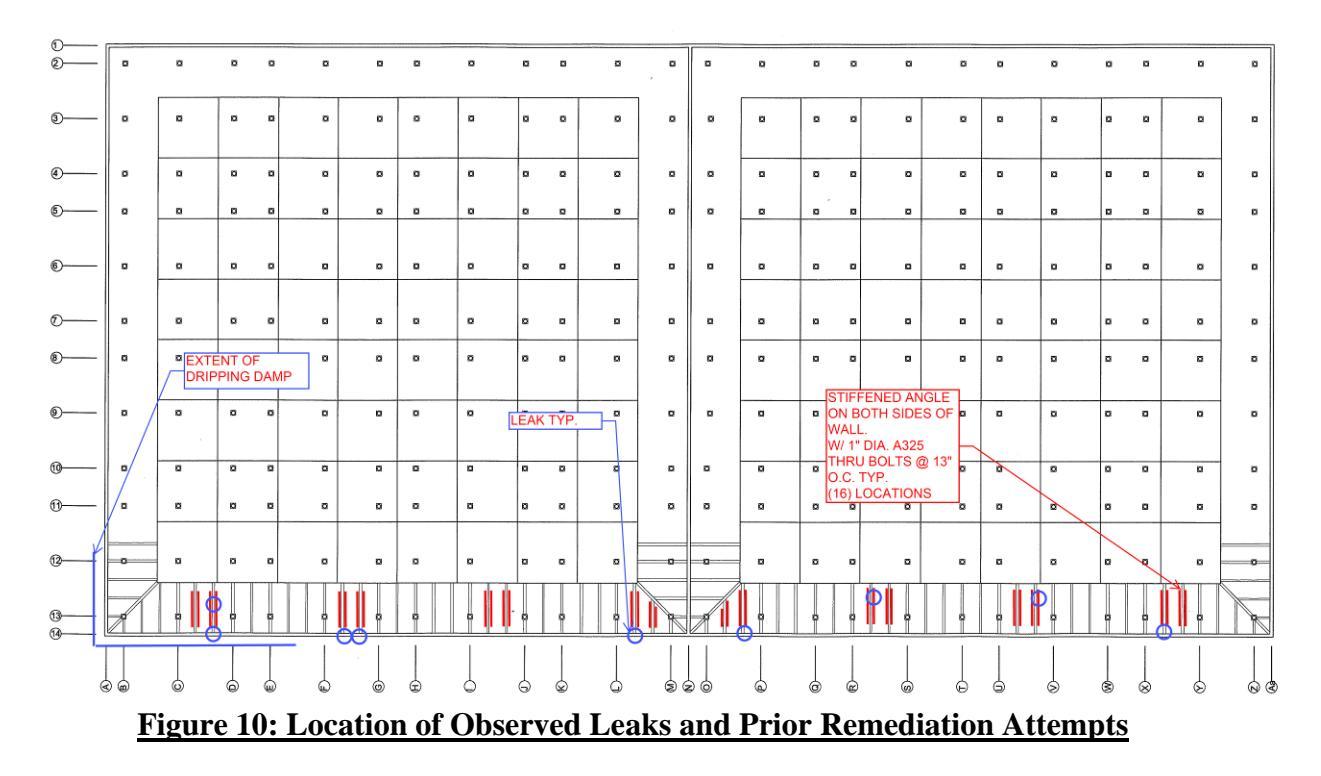
During our investigation of the support walls underneath the sloped floor on the eastern side of the reservoir we observed several active leaks. The locations of these leaks are noted by blue circles in Appendix Figure 10. The Appendix Figures 11 through 14 give a sense of the amount of water leaking at these locations. It was also observed that all of the leaks correspond to locations where stiffened angles on both sides of the support walls have been post-installed using 1" Ø A325 thru-bolts. The location of these angles are noted by solid red lines in Appendix Figure 10. The design and location of these angles follow, in part, the remedial recommendations and instructions found within OBEC's evaluation report. It was also observed that these leaks correspond to the closing strips of the sloped reservoir floor slabs and walls located directly above. It was observed that a remedial waterstop system consisting of flexible mastic with backer rod has been applied to all of these closing strips

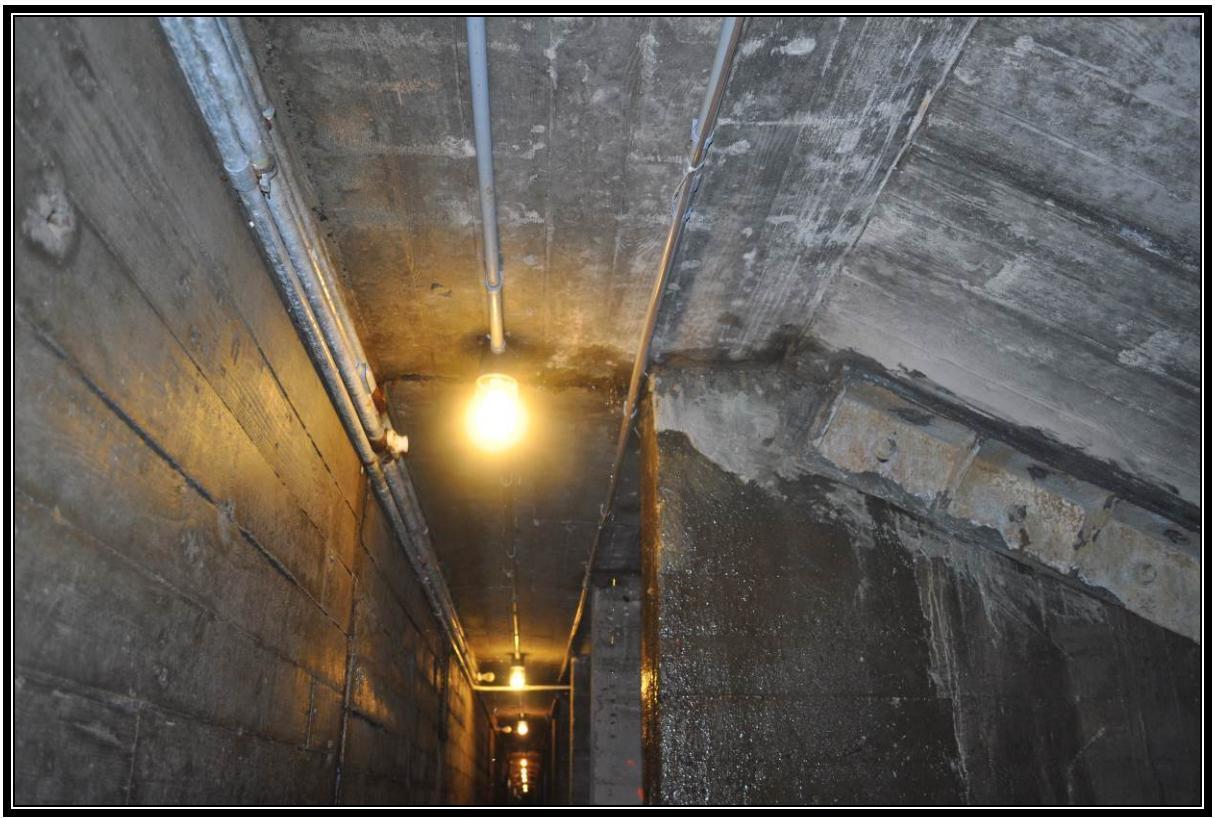
Figure 11: Leak Under Eastern Sloped Slab

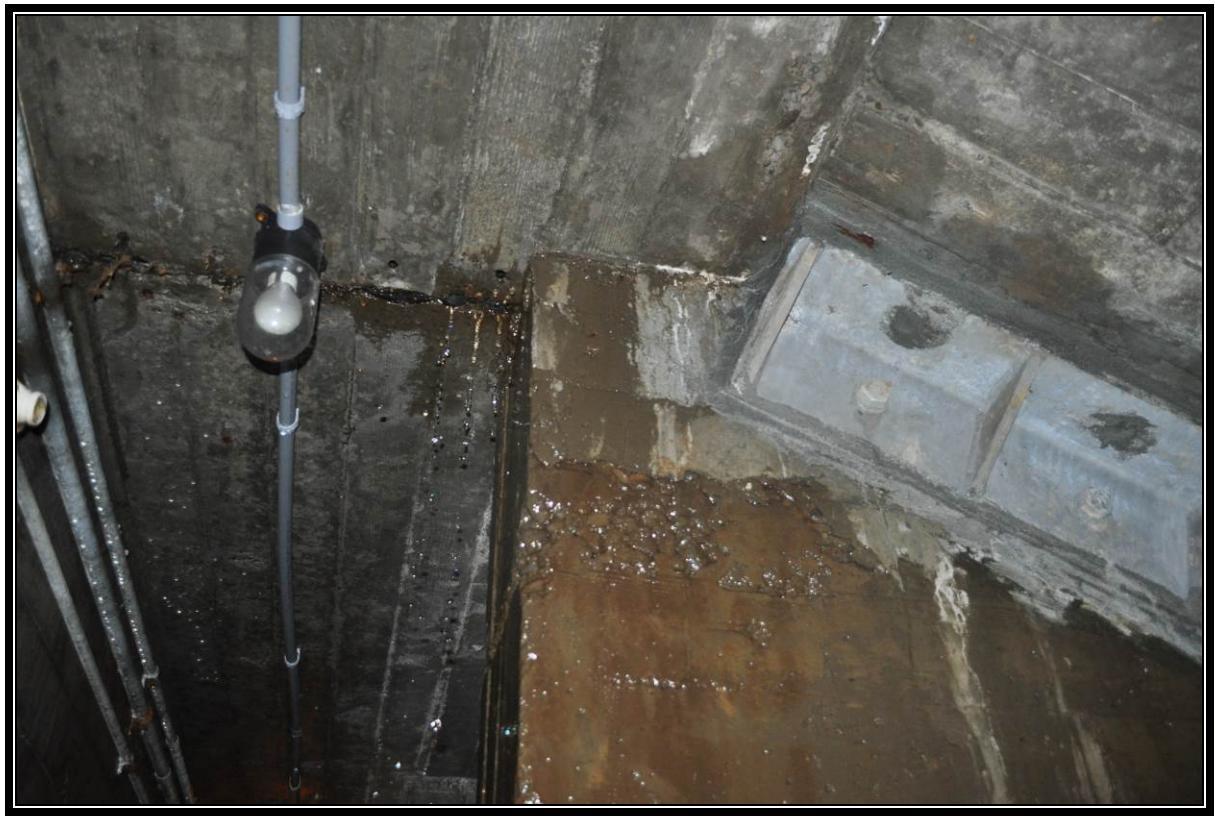
Figure 12: Leak Under Eastern Sloped Slab

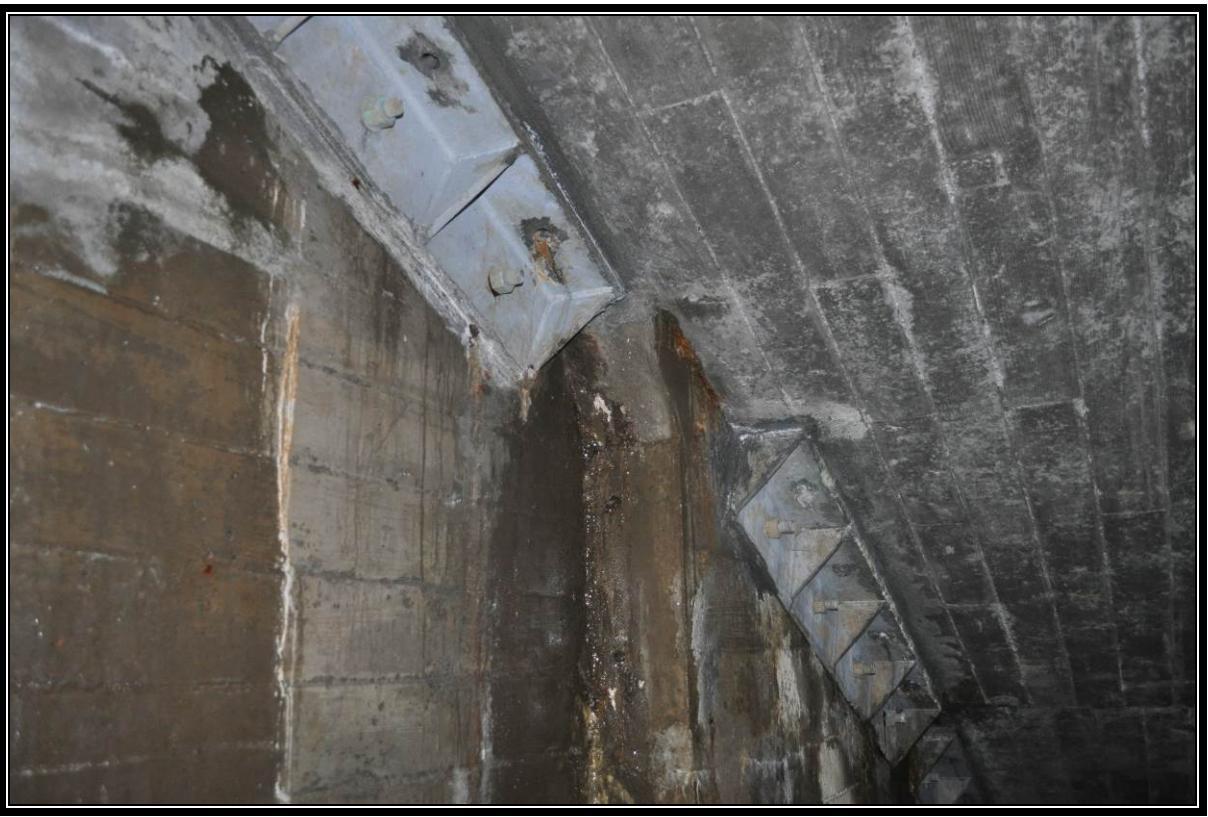
Figure 13: Leak Under Eastern Sloped Slab

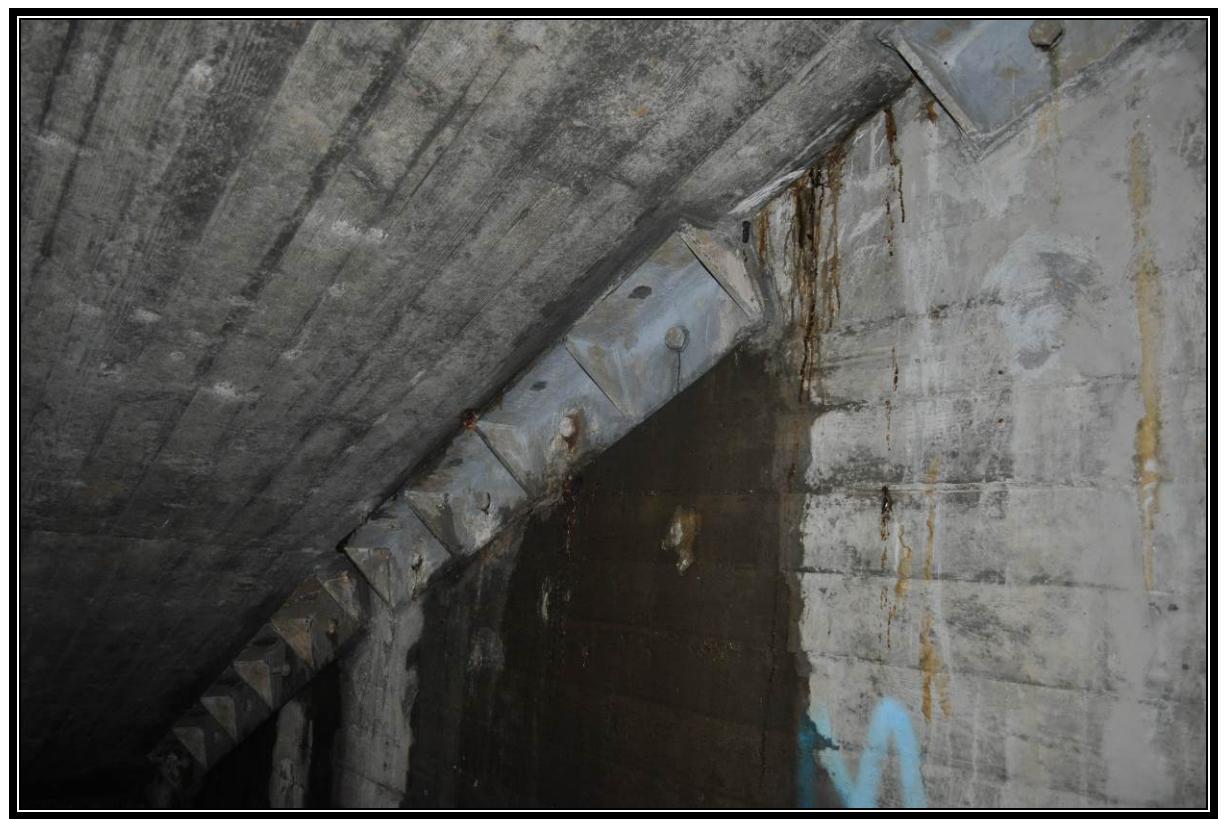
Figure 14: Leak Under Eastern Sloped Slab

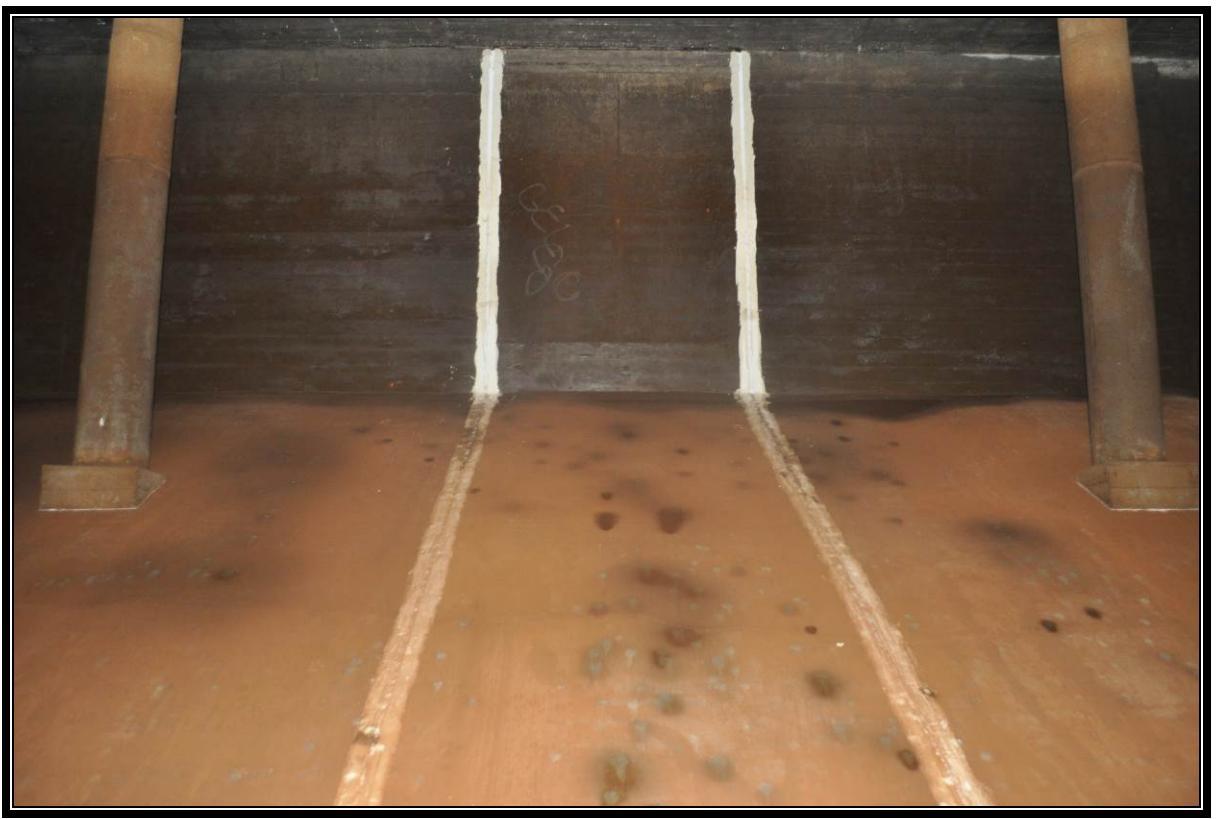
(see Appendix Figures 15 and 16). The consistent location of the leaks corresponding with these closing strips suggests a failure of the waterstop system at these joints.

Figure 15: Closing Strips of Sloped Slab and Wall

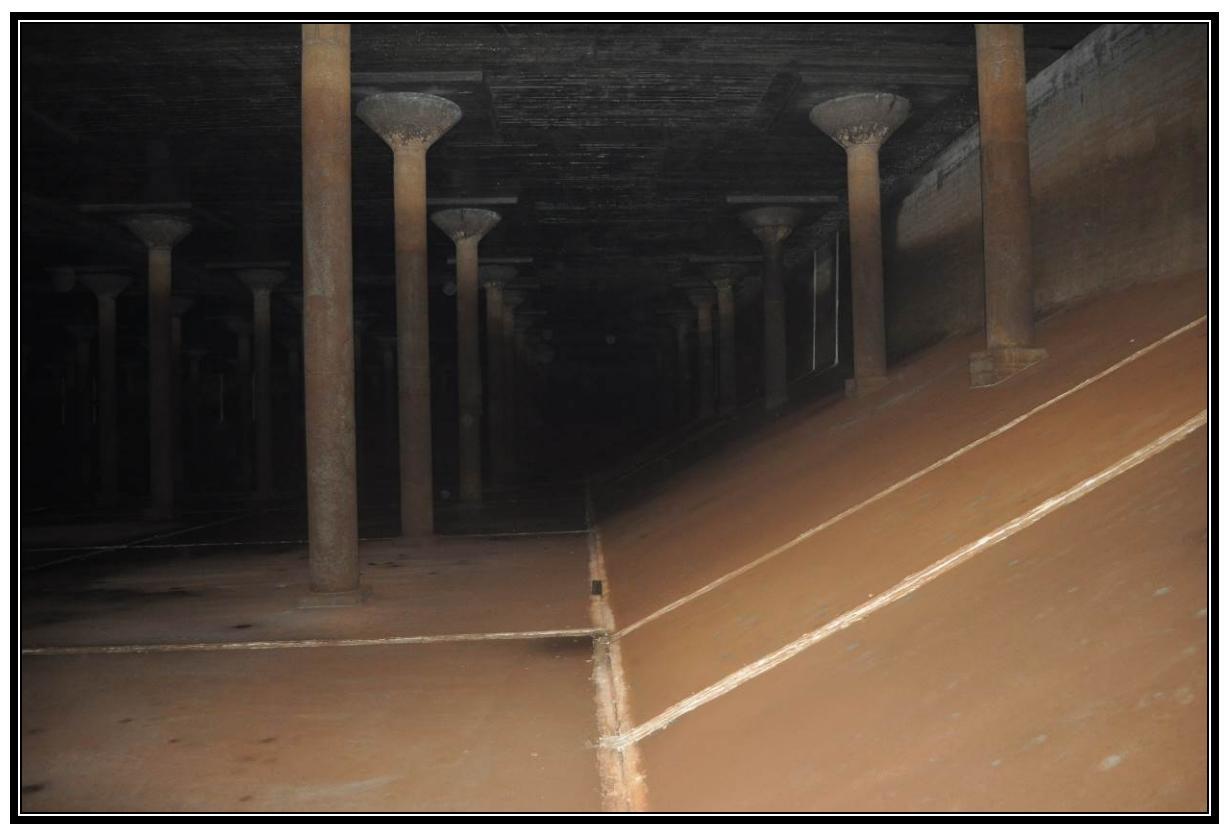
Figure 16: Closing Strips of Floor Slab, Sloped Slab and Wall

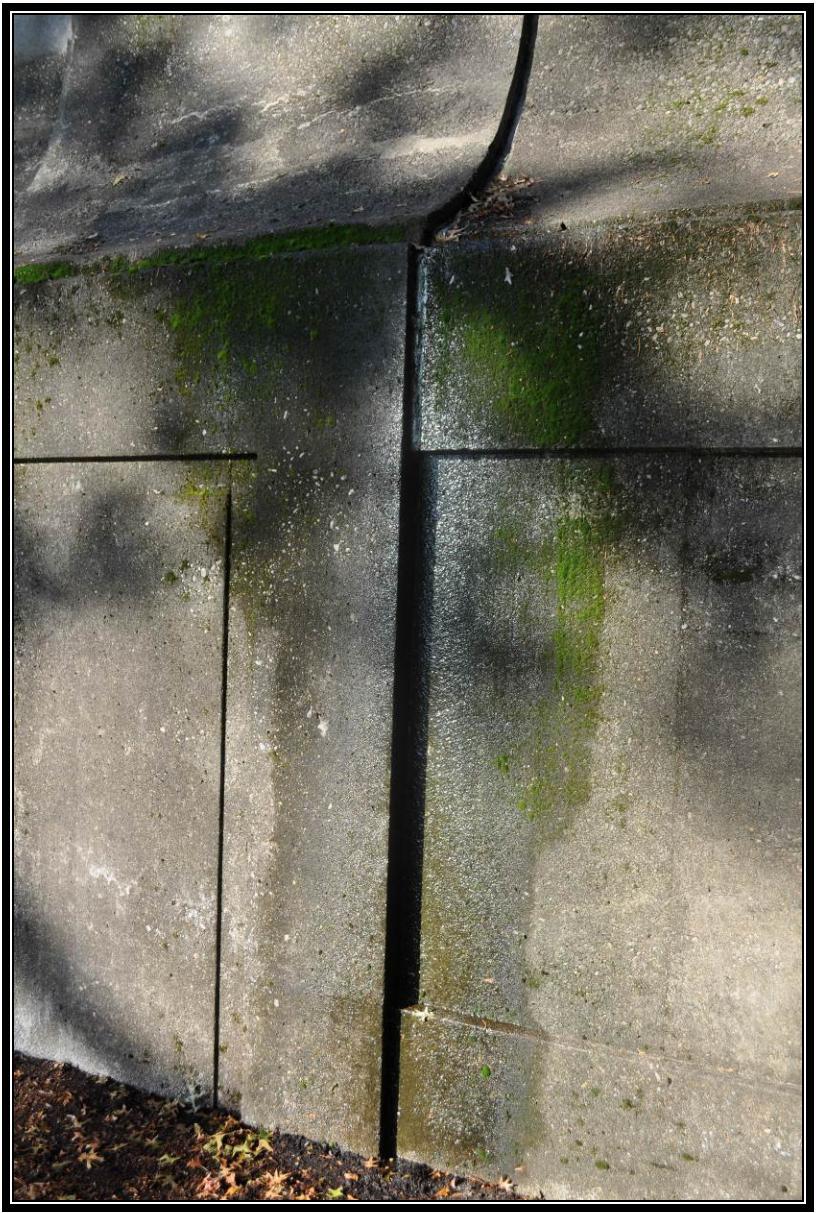
We observed that the reservoir is actively leaking through the exterior wall at the southeastern corner (see Appendix Figure 17). This location corresponds directly with one of the leaks observed in the support wall underneath the sloped floor and discussed above. It also corresponds with a wetted area within the access hallway where dampness and droplets were observed on the wall and ceiling. The extents of this dripping damp area extend in both directions from the south-east corner and are noted by a solid blue line in Appendix Figure 10. The leaking in this area appears likely attributable to the failing watersop system at the closing strips as noted above. However, considering the volume of water leaking at this location and the fact that the leak is penetrating through the exterior wall, this leak may be the result of an additional failure of the original 16 GA galvanized iron waterstop (see Appendix Figure 18).

Figure 17: Leak Through Exterior East Wall At South-East Corner

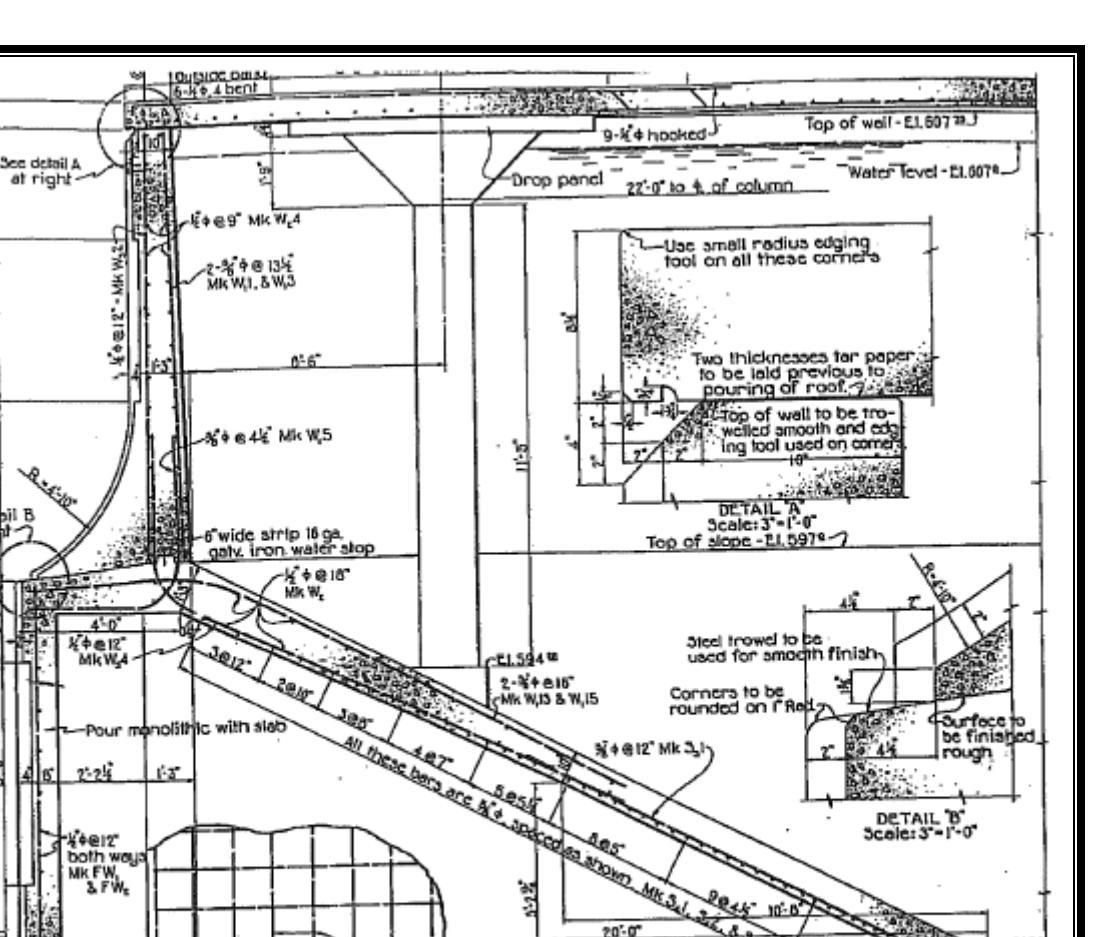
Figure 18: Original Construction Detail of Existing Exterior Wall Along Eastern Side
