EUGENE WATER & ELECTRIC BOARD

ECOLOGICAL INVENTORY REPORT

Final – February 2021

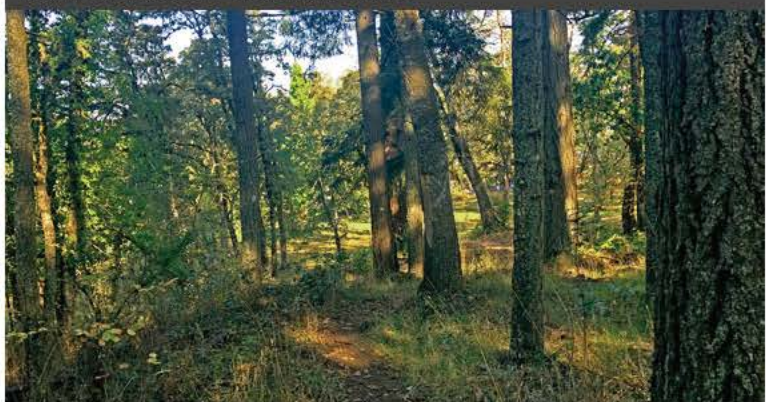
PHOTO 1: RIDGETOP INFORMAL TRAIL

The open space provided by the East 40th Avenue site is popular with nearby residents and EWEB is seeking to minimize impacts to the natural features of the site while providing necessary infrastructure improvements (Photo 1, Ridgetop Informal Trail).

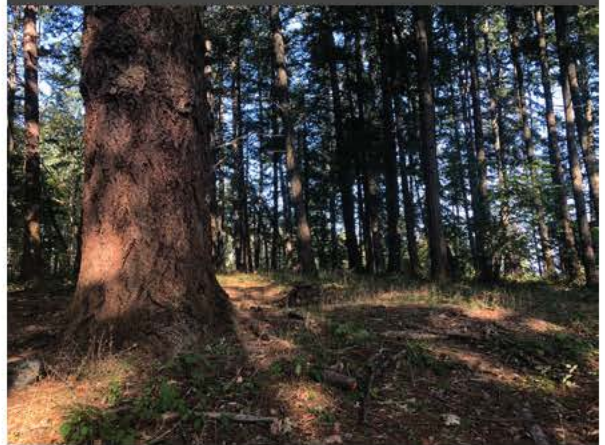
PHOTO 2: INTERIOR OF DOUGLAS FIR FOREST

While it does contain large trees, the Douglas fir forest present on the E. 40th Avenue site is not considered to be old-growth or late successional forest. Old-growth and late successional are interchangeable terms used to describe forests that have existed for many years, usually 200 years at least, and that have over time developed a complex structure. Late successional or old growth forests typically include very large diameter living trees, some with broken tops; living trees with large bark pockets and obvious signs of decay, and a high percentage of standing dead trees (snags) with large cavities or that are mostly hollow. These forests often include a sub canopy that includes smaller shade-tolerant trees, and a well-developed herbaceous understory. According to the Oregon Conservation Strategy, late successional mixed conifer forests are defined by plant species composition, overstory tree age and size, and the forest structure. They include characteristics such as a multi-layered tree canopy, shade-tolerant tree species growing in the understory, large-diameter trees, and a high volume of dead wood, such as snags and logs. Late Successional Conifer Forests are older forests (hundreds of years old), generally occurring below 3,500 feet, but sometimes occurring up to 4,000 feet. Western hemlock is almost always co-dominant and usually dominates the understory. The understory typically supports shrub and forb species, such as vine maple, salal, sword fern, Cascade Oregon grape, western rhododendron, huckleberries, twinflower, vanilla leaf, and oxalis. In the absence of disturbance, Douglas-fir forests eventually will convert to western hemlock .

The conifer forest on the East 40th Avenue site contains some large Douglas fir trees but does not contain very large diameter trees, or more than just a few trees with broken tops, or any large trees with obvious signs of decay. The relatively low percentage of standing dead trees, the lack of an understory layer of smaller shade -tolerant trees, and the very minimal herbaceous understory are features that do not support characterizing the site as late successional/old-growth forest.

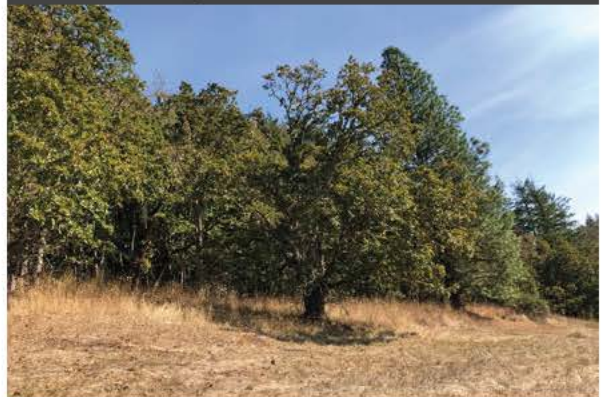
PHOTO 6: SOUTHERN EDGE OF MIXED FOREST (NOTE PONDEROSA PINE)

and Oregon grape. The outer southern edges of this plant community also support Oregon white oaks. The presence of ponderosa pine in this forest is somewhat notable as this native pine is becoming less common in the Willamette Valley and is recognized by ecologists as a species that should be promoted and managed for when possible.

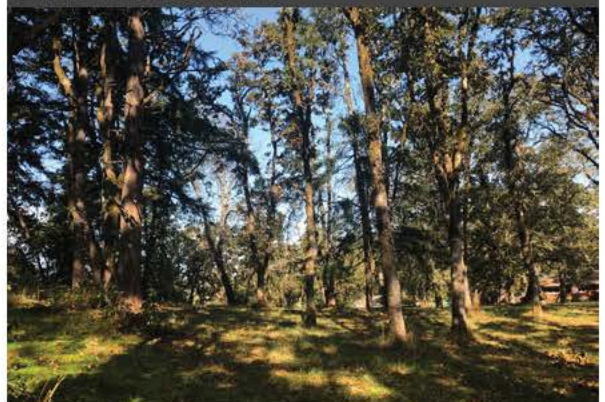
PHOTO 8: OAK WOODLAND

Due to the relatively wide spacing of the trees, and the open and relatively weed-free understory, the oak woodland on the northwest side of the property provides moderate to high habitat value. This area also offers good opportunities for habitat restoration/enhancement due to its relatively healthy condition.

- Enhancing the oak habitat by removing ivy and poison oak and removing conifers that are currently shading the edges of the oak woodland
- Creating openings in the remaining Douglas forest canopy to create conditions that would favor additional light-tolerant plant species to establish
- Repurposing felled trees as installed snags to provide additional structural habitat in the currently snag-deficient forest
- Enhancing the meadow area to provide pollinator habitat, and potentially recreate an oak savanna habitat.

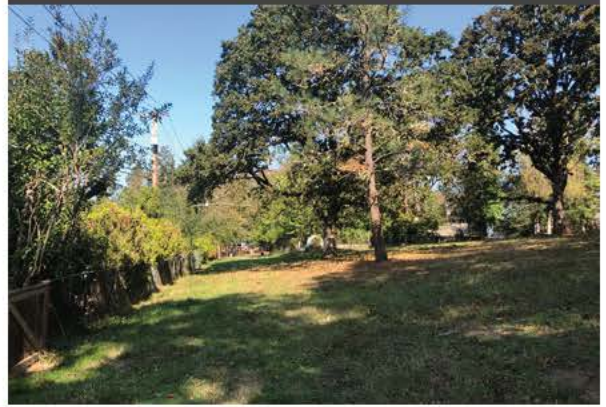
PHOTO 9: OAK SAVANNA

The northeast and southwest corners of the site support a regularly mown meadow. The meadows are characterized by grasses and weedy forbs including fescue, bluegrass, dandelion, and Queen Anne's lace. Local naturalists report that these areas support three native bunchgrass species that are considered cornerstone species of native Willamette Valley upland prairies, as well as wildflowers including camas, western buttercup, and fawn lily. While these native plant species do not dominate the meadows, their presence suggests these area could be managed in such a way as to reestablish a native prairie habitat that could support additional native plants as well as insects including butterflies and other native pollinator species.

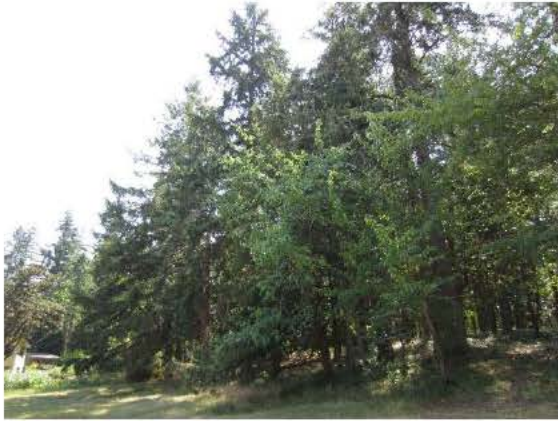
Douglas Fir Woodland

The Douglas fir woodland is a healthy mix of young trees and old trees, dead trees, and openings. While predominately Douglas fir, a few different species were also seen. There are several areas in the forest where trees are thick and compete for light, nutrients, soil, and water. Very thin canopies with vegetation only at the tops are the result of this. Thinning of the forest in several locations would benefit some of the younger trees and could help to create a stronger forest. Trees to consider thinning would be those with damaged tops, those with multiple tops, those that are competing heavily with their neighbors for space/sunlight, those with disease or pest, those physically resting on others, and those with any sort of health defect that renders them of less value than another.

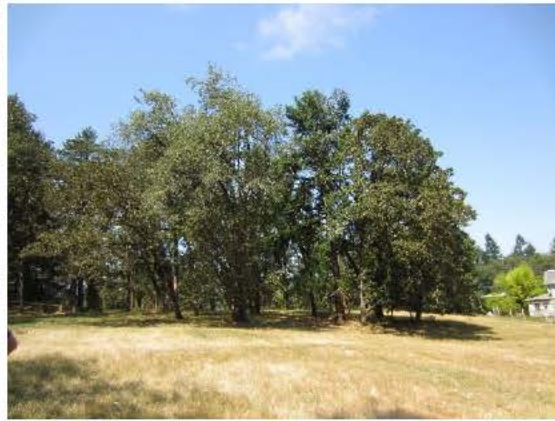
Oak Woodland

The site is currently an undeveloped natural area comprised of woodlands along the ridgeline and meadows on the northeast and southwest corners of the property. It appears some maintenance and care has been given to the site. Few noxious species were seen. Evidence suggests that occasional mowing occurs which helps keep the noxious species that were seen at bay. Walkers frequent the pedestrian trails winding along the ridgeline in the middle of the woodland. There are two distinct woodlands on the site: a Douglas fir woodland and an Oak woodland. Overlap of the two occurs. Both types of forests are very indicative of this area in the Pacific Northwest and this site has both. Prior to European settlement, the Oak woodland was the predominant type of woodland in the Willamette Valley. Since then, without the historic burning of the Willamette Valley, a natural succession to Douglas Fir woodlands has prevailed.

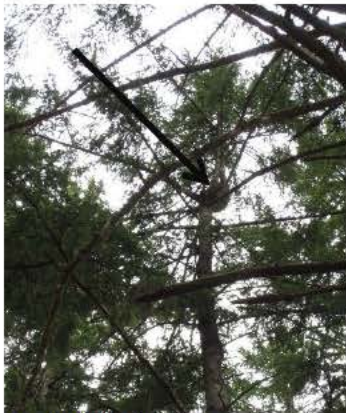
Co-dominant leaders

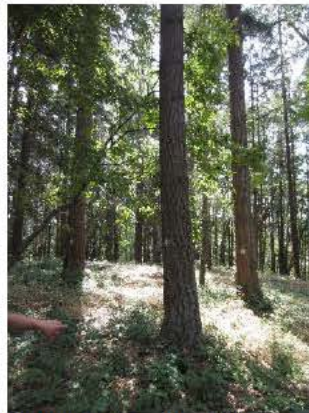
Open understory: bramble

UPDATE: The relatively open understory of the Douglas fir woodland is teeming with *Toxicodendron diversilobum* (Poison Oak), *Hedera helix* (English Ivy) and blackberry species, in addition to the usual innocuous natives. In addition to Poison Oak and English Ivy, Wisteria and Honeysuckle vines were also noted as climbing several of the trees. English Ivy in particular causes bark damage when allowed to climb unchecked, and removal is difficult without causing more harm to the tree. There were several cases of extreme ivy infestation. This noxious species should be brought under control to avoid spread and damage to the woodland over time.

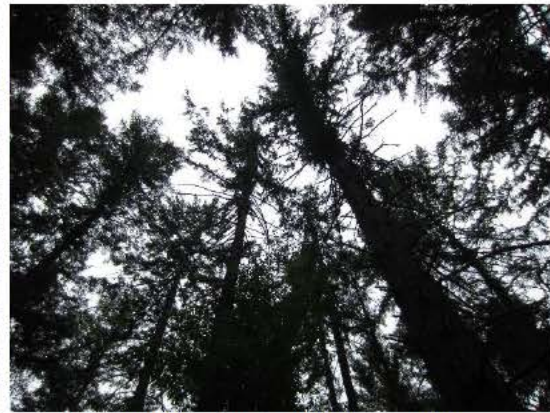
Canopies: some opening & some overcrowding

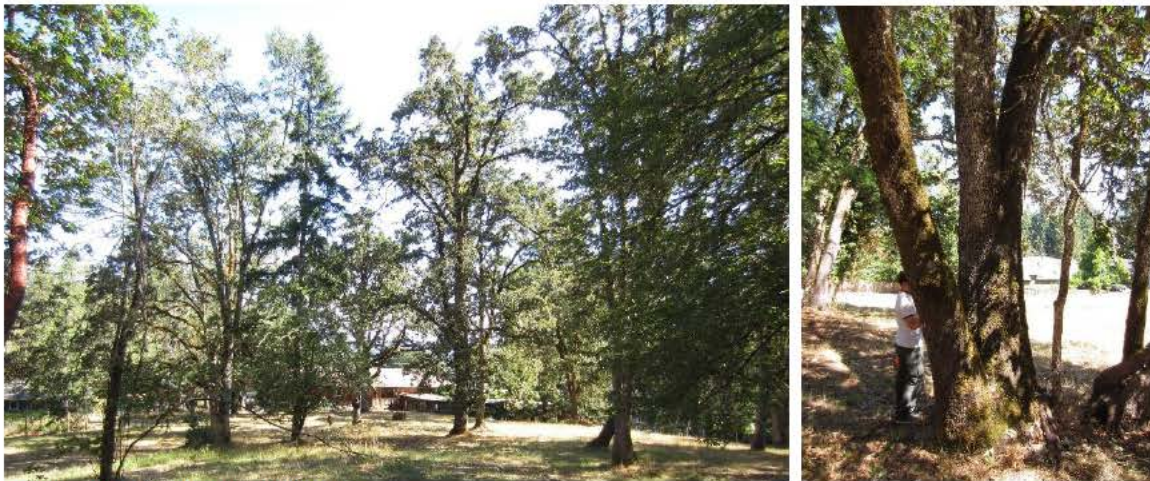
The Oak woodland has some open canopy spaces with the help of maintenance and storm damage. Without maintenance, the Douglas fir woodland could and would take over. Some thinning has occurred either by restoration efforts or due to storm damage. Opening up the canopy and allowing for more horizontal growth can benefit an Oak woodland. Most of the dieback on the Oaks is due to the Douglas firs outcompeting the Oaks for available sunlight, nutrients, and space. To help strengthen the Oak woodland, it is recommended to remove the Douglas firs that are outcompeting the oaks, meaning, any Douglas Fir that is within 10 ft of an Oak’s canopy, should be removed if it is deemed a priority to keep the Oaks. The understory under the Oaks has been maintained as well, more so than within the Douglas fir forest.

Oak woodland with grass understory

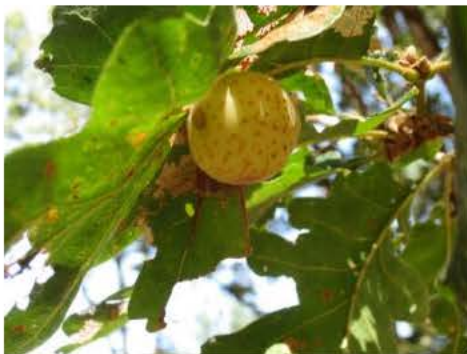
The majority of the oaks had skeletonized leaves which is indicative of pests. As the trees are more mature, the trees did not seem to be significantly affected by the pest damage. In addition, the majority of the Oaks had galls caused by oak apple gall wasps. Galls usually occur on leaves and stems, but also may occur on flowers, fruits, twigs, branches, trunks, and roots. Gall-making insects are generally not considered pests as they do not damage the oak tree host but may cause earlier defoliation. Although there are some insecticides registered for use against gall-making insects, their use is generally unwarranted, and not recommended here. Furthermore, pesticides may kill beneficial insects that help control gall-making insects and could damage the health of the woodland’s ecosystem.

Oakleaf Galls

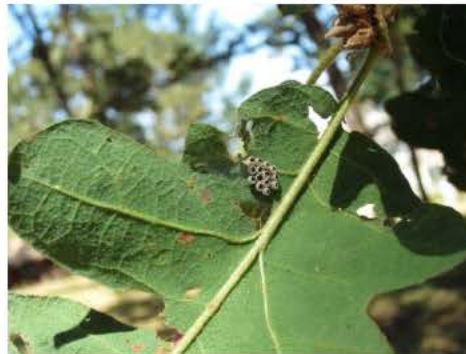
Insects

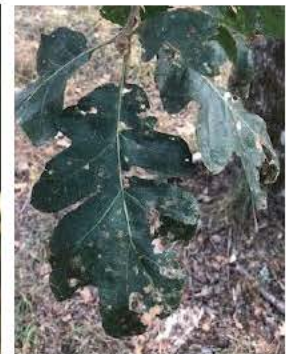
Skeletonized leaves

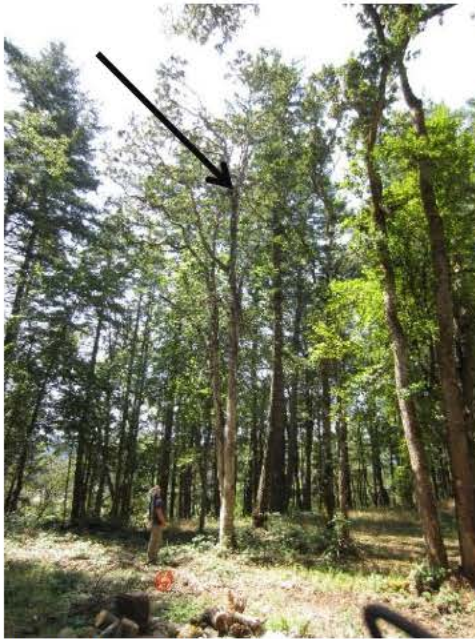
Possible Nest in Oak

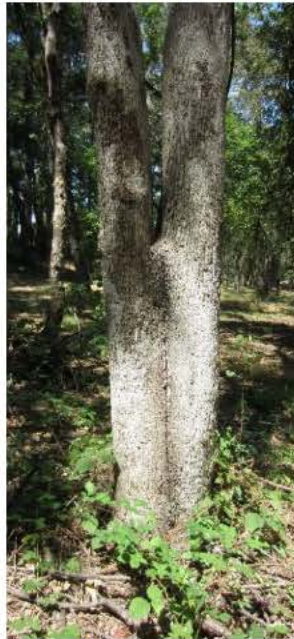
Inosculation

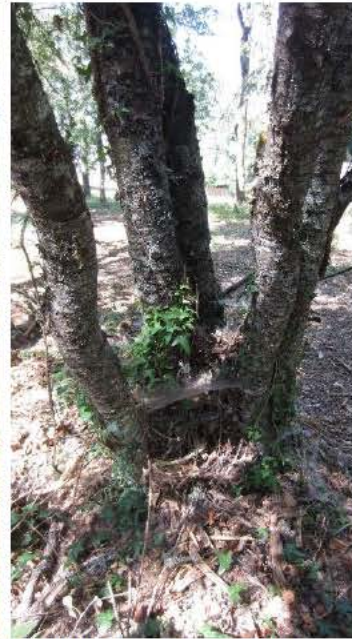
The understory is thin, with a mix of native understory and noxious species, comprised of *Rubus ursinus*, the native blackberry and *Rubus armeniacus*, Himalayan blackberry. In addition and much to my dismay, a healthy amount of *Toxicodendron diversilobum*, Poison Oak is scattered around. Mowing has helped keep the understory controlled, but there are still areas of thick poison oak which made it difficult to take some tree measurements. Honeysuckle vines were also seen climbing on at least a dozen of the Oaks. Noxious species with the ability to do tree damage include *Hedera helix*, English Ivy. For a forest of this size, little ivy was seen but it's location was tracked and can be seen more precisely within the individual tree data tables. Without proper maintenance, English Ivy has the ability to take over and can damage the full woodland of trees. Currently, it has a scattered existence throughout the woodland.

English Ivy beginning to climb

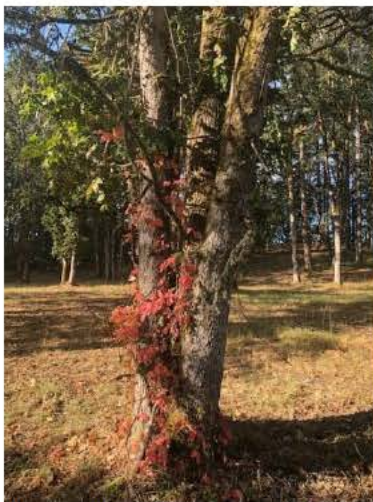
Poison Oak vines climbing trunk

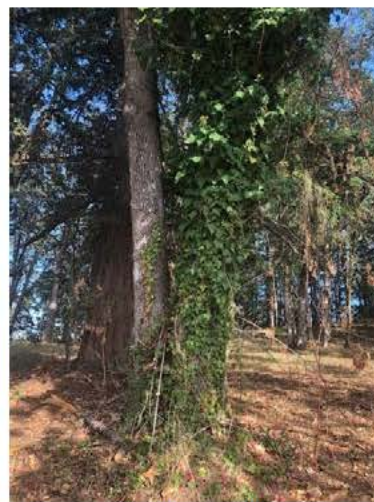
English Ivy climbing trunk

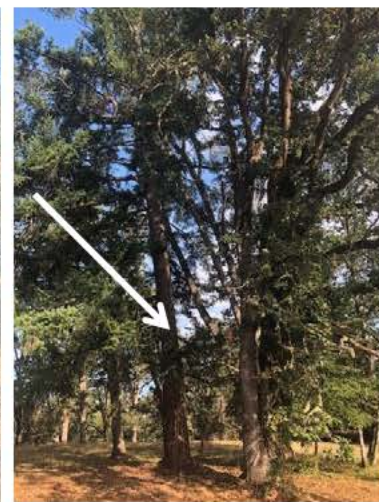
Fir outcompeting Oaks
