2022

State of the McKenzie Watershed Report

Eugene Water & Electric Board

February 2023

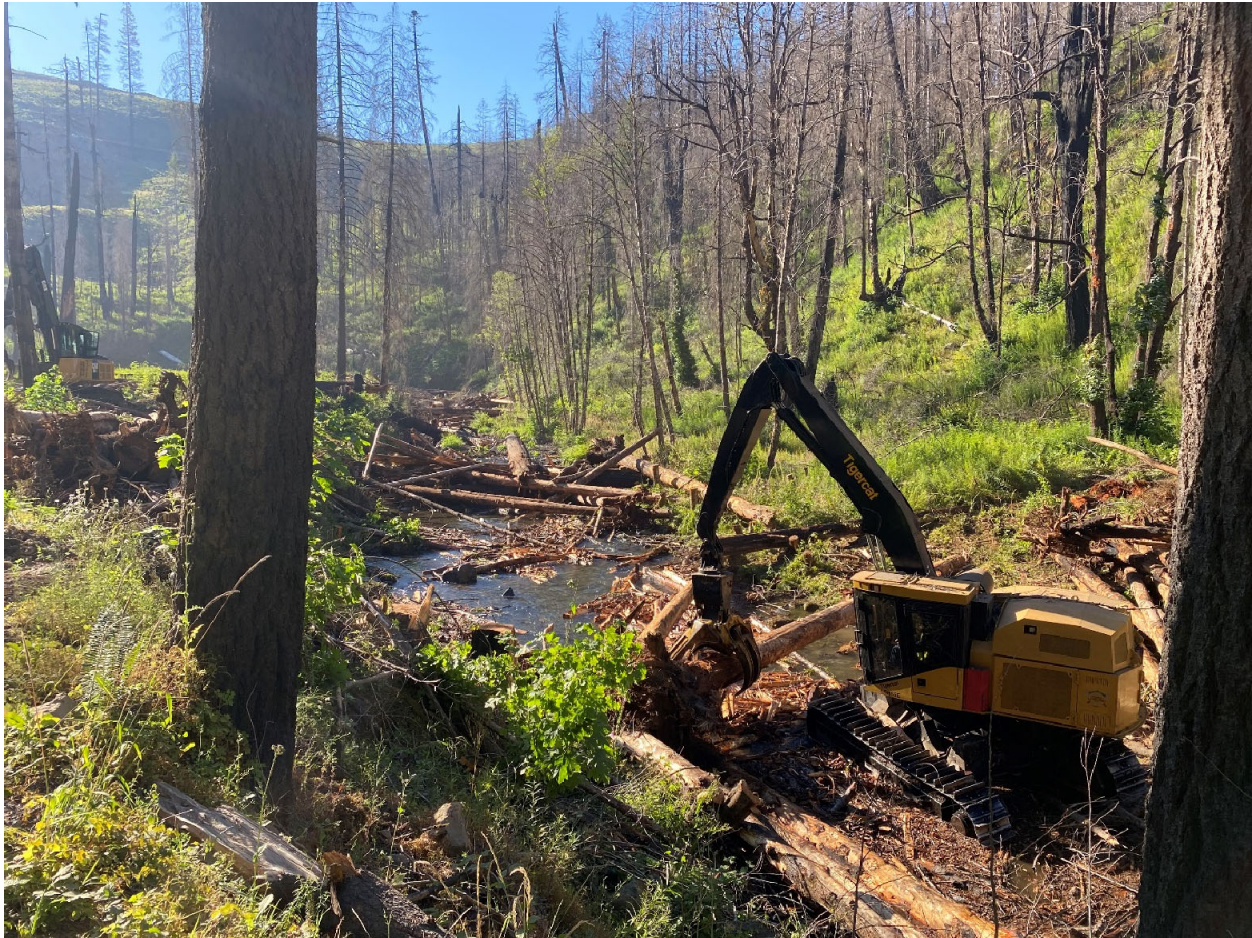
Figure 1-2: Gate Creek Large Wood Placement

We continue to work with The McKenzie Watershed Council (MWC), the McKenzie River Trust (MRT), and the U.S. Forest Service (USFS) to implement two different types of large-scale restoration projects. In 2022, we worked on large-scale wood placement at Gate Creek and floodplain restoration in Deer Creek. We also continued project design for Finn Rock Phase II and Quartz Creek. These types of restoration have numerous benefits including, mitigating floods, turbidity, and organic carbon by spreading out and attenuating flows, dropping out sediment, increasing the uptake of nutrients and organic carbon coming from upstream severely burned landscapes, water storage, increasing habitat for fish and wildlife, protection from fire, and increasing cold water refugia.

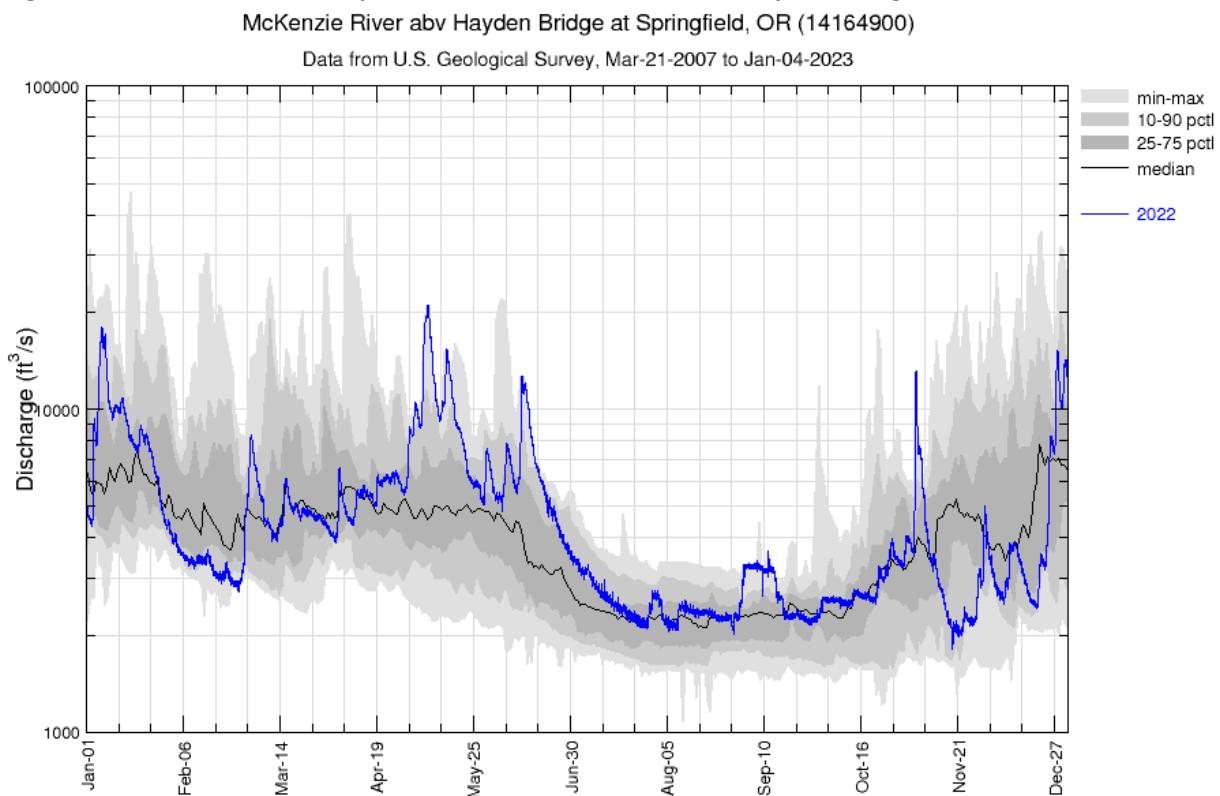
Figure 2-1: Historic Flow Comparison, McKenzie River above Hayden Bridge

Flow in the McKenzie River at Hayden Bridge during the 2022 calendar year generally stayed close to median values (see Figure 2-1). Notable exceptions include a period of lower flow during a prolonged dry stretch in February, followed by higher-than-normal flows in May and June as a result of several large, late spring storm events. Cougar Reservoir was also bypassing higher flows in May, which contributed to higher mainstem McKenzie flows late spring and into early summer. After a large storm system passed through the area in early November, flows dropped again by mid-November and into December with lower-than-normal precipitation amounts falling mostly as snow in the higher elevations. The highest flow observed at Hayden Bridge during 2022 was 20,900 cubic feet per second (cfs), which occurred on May 7th.

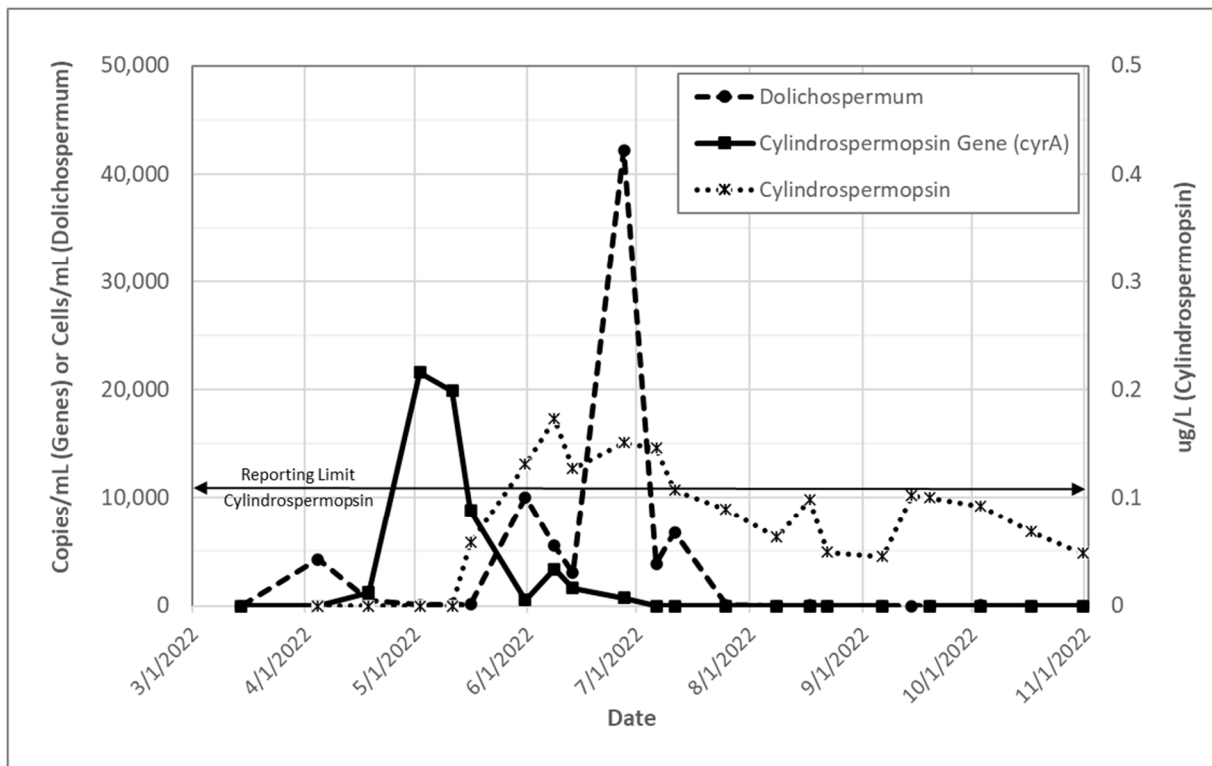
Figure 3-2: 2022 HAB result summary for Blue River Reservoir near the dam

Cyanobacterial blooms in both Blue River Reservoir (BRR) and Cougar Reservoir (CR) during 2022 deviated slightly from typical patterns observed over previous years, with blooms peaking slightly later in 2022. *Dolichospermum* first appeared in BRR beginning in April, and then in CR around mid-June. *Dolichospermum* concentrations initially climbed in late May for BRR (15,400 cells/mL), but then declined in early June as wet weather conditions returned to the area (see Figure 3-2). Numbers in BRR rebounded and peaked in late June (42,200 cells/mL) near the dam, with a second peak occurring at the east end of BRR near the boat dock (27,040 cells/mL) around mid-July. *Dolichospermum* peaked in CR in early July. By early August *Dolichospermum* numbers were low in both reservoirs.

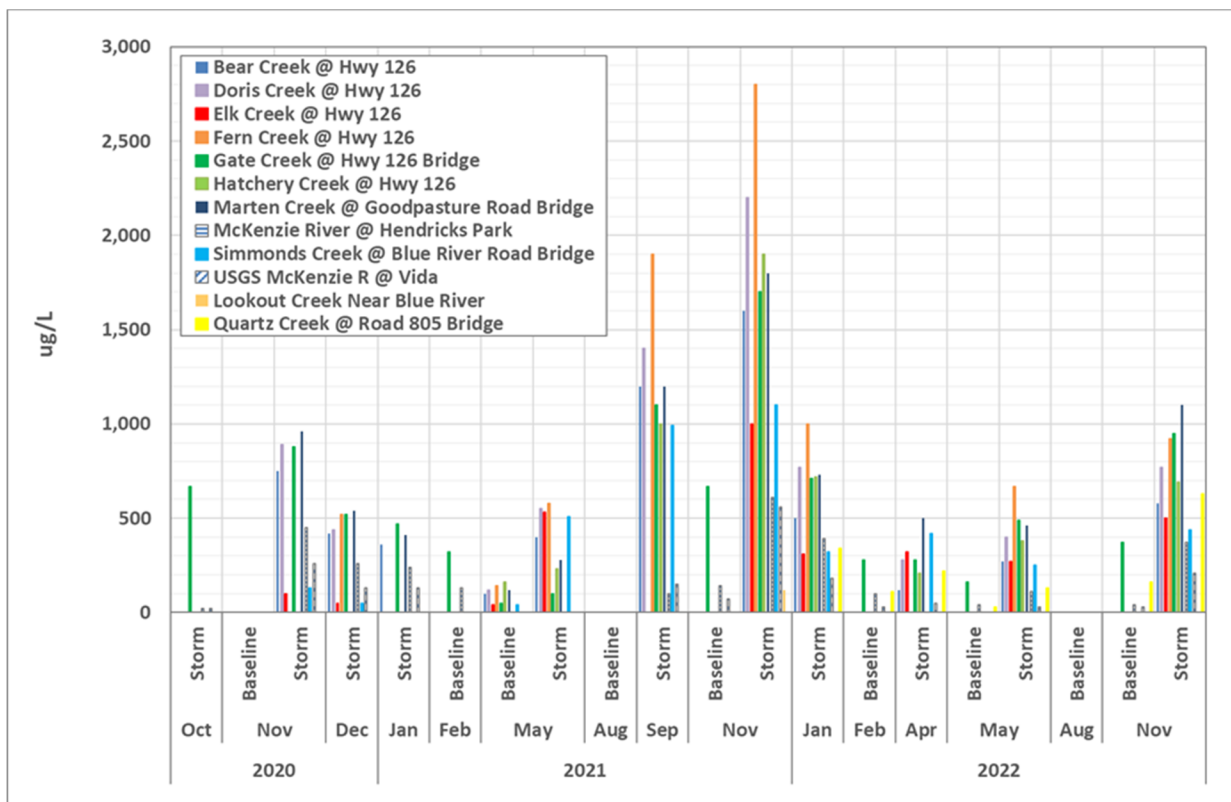
Figure 3-5: Nitrate Results, Holiday Farm Fire Monitoring Locations

Nitrate levels at HFF sites during four different 2022 storm events were generally lower than results reported for storm events in 2021 (see Figure 3-5). HFF nitrate levels only exceeded 1 mg/L in 2022 on a single occasion when Marten Creek reached 1.1 mg/L during a storm event in November. The highest nitrate values observed in 2022 across all sites were found in the 52nd stormwater channel, with all 4 baseline values exceeding 1.5 mg/L. Keizer Slough (1.4 mg/L) and Cedar Creek (1.3 mg/L) reported the next highest values during a February baseline event. One site worth keeping an eye on is Cedar Creek, where over the past 5 years nitrate values during the 1st quarter appear to be on an increasing trend, with a peak value of 1.3 mg/L in 2022 (.65 mg/L in 2018). All of these values are well below the nitrate drinking water MCL at 10 mg/L.

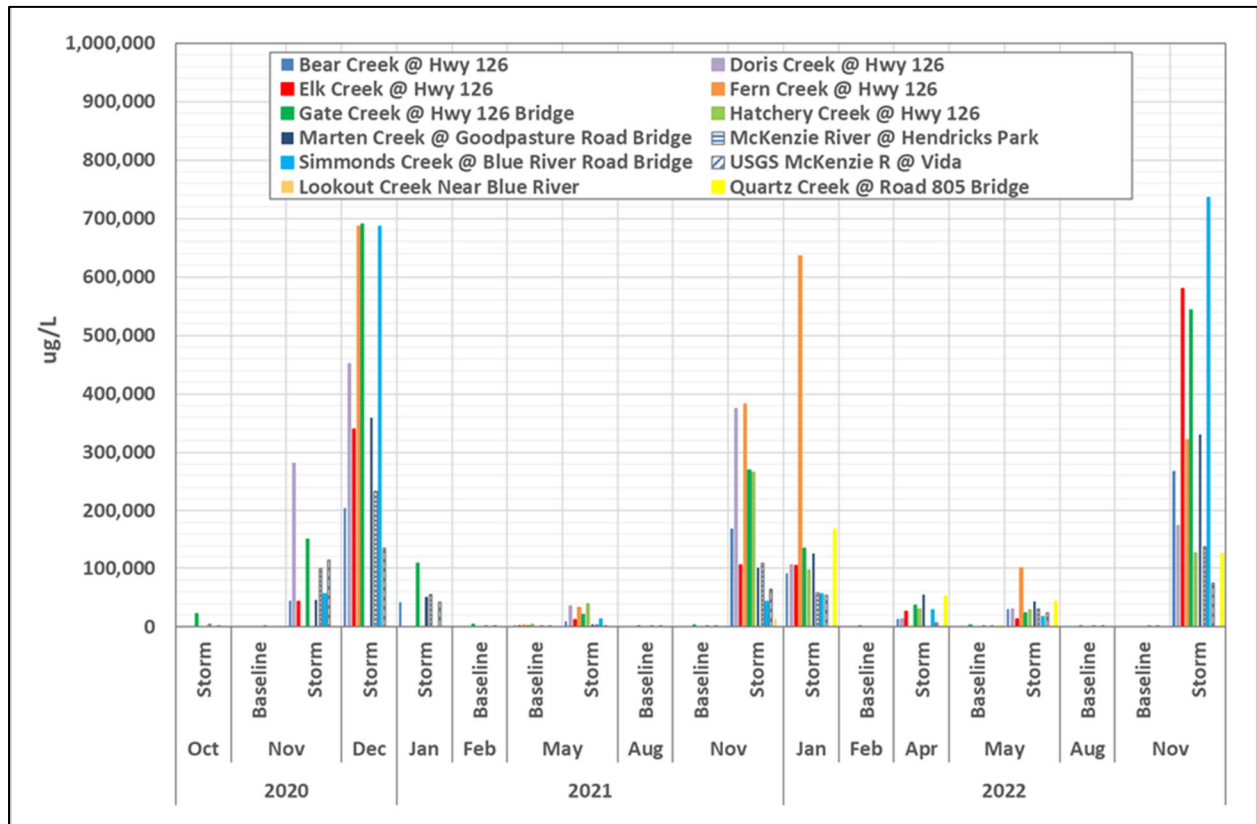
Figure 3-6: Total Suspended Solids Across Multiple Holiday Farm Fire Sites, 2022.

Solids can carry contaminants and pathogens through the watershed impacting ecosystem function as well as being a concern for drinking water treatment, particularly around filtration processes. Results for total suspended solids (TSS) and total dissolved solids (TDS) were typical across most sites during baseline conditions and relatively small storm events. However, unusually high TSS values were observed across multiple HFF sites in 2022 (see Figure 3-6), starting with Fern Creek (636 mg/L, or 636,000 ug/L) during a January storm event, and then across several sites following a large November storm event when the northeast portion of the watershed received nearly 4 inches of rain over a 36-hour period. Simmonds Creek reported the highest TSS concentration at 736 mg/L during the November storm event, along with some of the highest flows ever observed at this site post-HFF. Two other sites, Gate Creek and Elk Creek, both climbed above 500 mg/L during the same event. These values are similar in magnitude to those observed immediately after the Holiday Farm Fire during a particularly large storm event in 2020. Higher TSS values have only been observed on two other occasions over the past 15 years, including the 2021 Blue River Reservoir drawdown event (1,740 mg/L), and in 2018 following a storm event within the Terwilliger Fire burn area (Smith Creek at 1,330 mg/L and Boone Creek at 1,004 mg/L). In fact, when looking at all non-wildfire sites over the same 15 year period, TSS has only climbed above 300 mg/L on two occasions, first during a 2017 storm event (Camp Creek at 428 mg/L), and then more recently during the November 2022 storm (52nd stormwater channel at 446 mg/L). These results clearly demonstrate the impact large wildfires can have on mobilizing sediment, particularly during large storm events involving high rainfall intensities.

Contrary to the HFF TSS values, total dissolved solids (TDS) remain highest in urban stormwater systems when compared to all other sites. In 2022, the 52nd stormwater channel routinely exceeded 125 mg/L during baseline conditions, with a historical peak value of 250 mg/L following a rainfall event in September, 2020. With respect to HFF sites, Fern Creek reported the highest TDS concentration at 110 mg/L following a storm event near the start of 2022. This is somewhat remarkable considering no other HFF site has ever exceeded 75 mg/L.

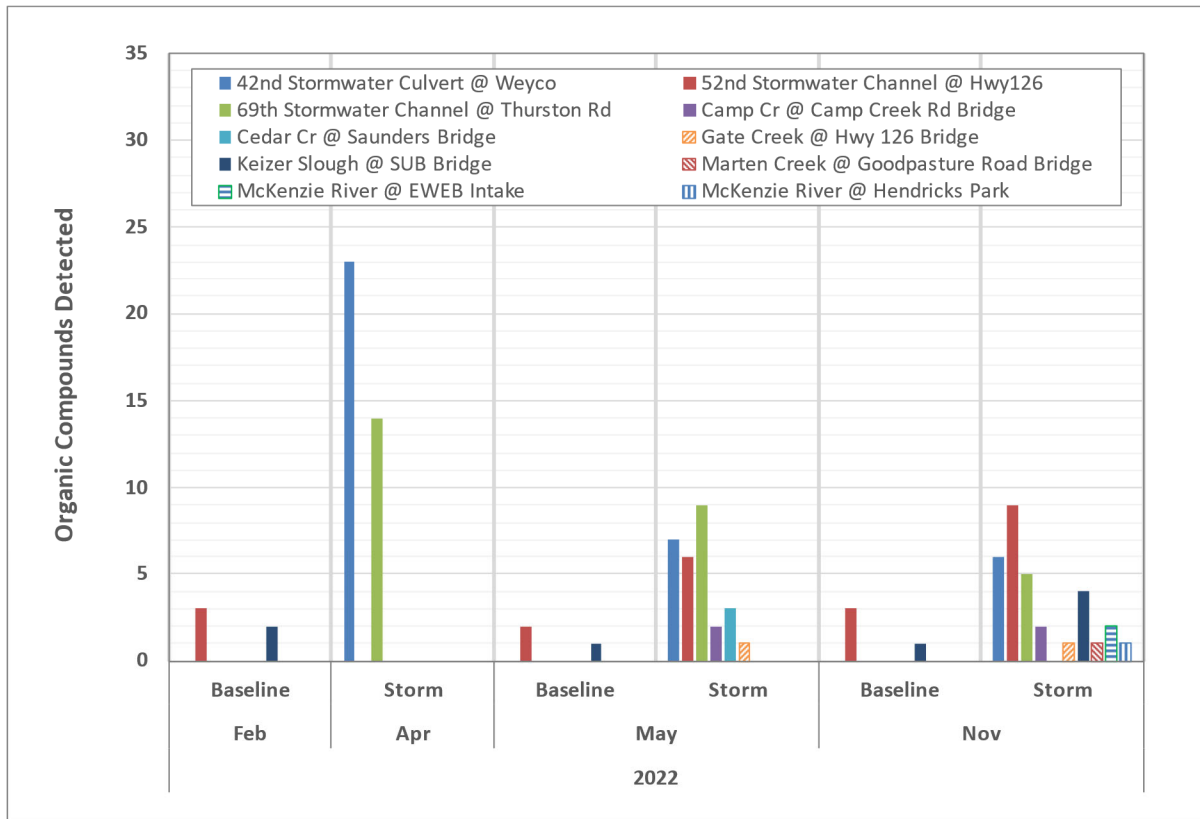
Figure 3-7: Organic Compounds Detected Above Method Reporting Limits by Site, 2022.

Most organic compounds detected in 2022 originated from urban stormwater outfalls located in the eastern portion of Springfield. As indicated in Figure 3-7, the 42nd and 69th stormwater channels registered the highest number of detections during a spring storm event in April. The 52nd stormwater channel had the highest number of detections in the fall during an early November storm event.

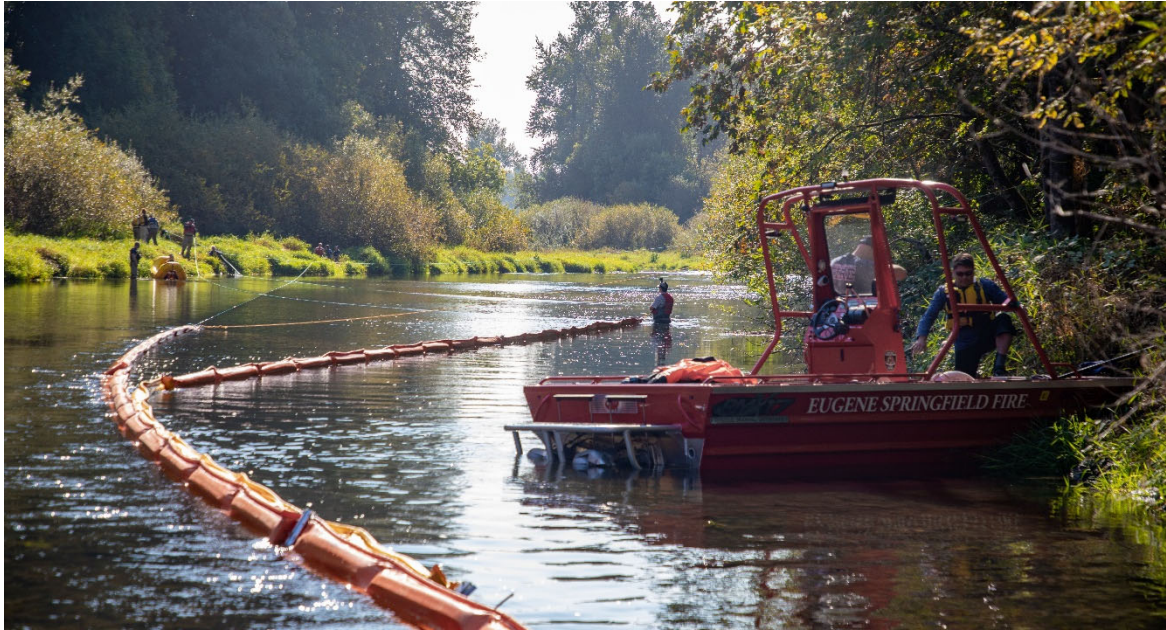
Figure 4-1: Boom Deployment Drill, Willamette River at Whiteley Landing County Park, 2022

EWEB worked with multiple partners to coordinate a multi-agency spill response drill on the Willamette River this past fall (see Figure 4-1). Equipment from the McKenzie Watershed Emergency Response System (MWERS) was used to deploy boom across a segment of the Willamette River downstream of

Eugene. The drill gives first responders an opportunity to familiarize themselves with equipment and to test out new response strategies. Several MWERS partners are interested in deploying boom in the Willamette River since they would likely respond to actual spills anywhere in the Upper Willamette River Basin.

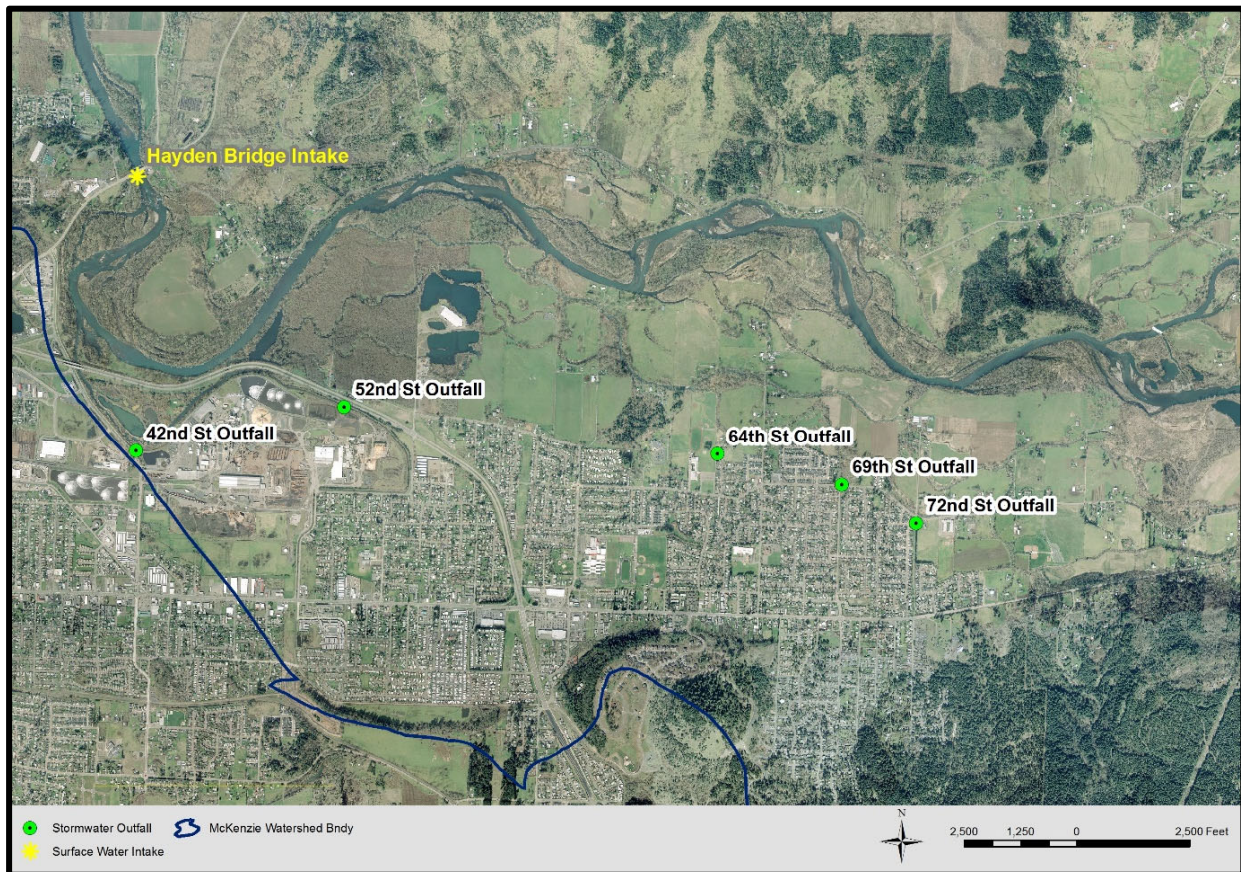
Figure 5-1: Stormwater Outfalls in East Springfield

Urban runoff is a concern especially in the lower part of the McKenzie Watershed which includes parts of East Springfield. Several stormwater outfalls (i.e., 42nd St., 52nd St., 64th St., 69th St., and 72nd St.) discharge into Cedar Creek and Keizer Slough, and then into the McKenzie River just upstream from EWEB's intake (see Figure 5-1). This area also contains a number of Springfield Utility Board (SUB) and Rainbow Water municipal well fields.

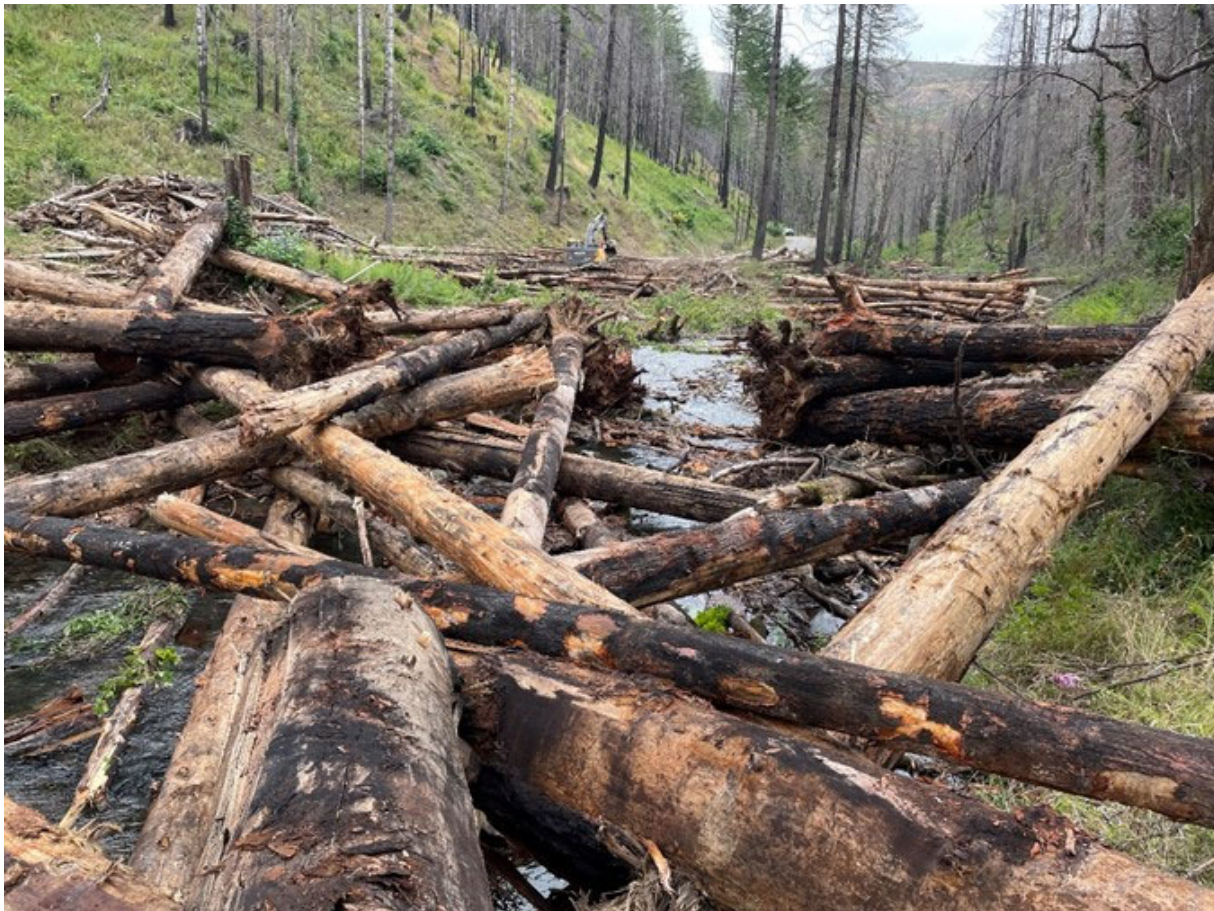
Figure 7-4: Instream Restoration on North Fork Gate Creek.

Gate Creek is a priority area for source water protection and supports a small run of Chinook salmon and provides critical habitat for rainbow trout and other native fishes. The BLM land on the North Fork Gate Creek was identified as an initial priority area for restoration work in the Gate Creek Watershed. The resulting restoration project, completed in August of 2022, added large wood to a 0.6-mile reach of North Fork Gate Creek. The wood for instream placement was sourced from hazard tree removal along the road adjacent to the project area. The project will increase the connection with nearly 10 acres of floodplain and help create pools and store spawning gravel. This project was completed in partnership between the McKenzie Watershed Council, BLM, and EWEB, the project funder (OWEB), and the skilled contractors who made the project happen (see Figure 7-4).
