EUGENE WATER & ELECTRIC BOARD

# State of the McKenzie Watershed Report

## Eugene Water & Electric Board

February 2023

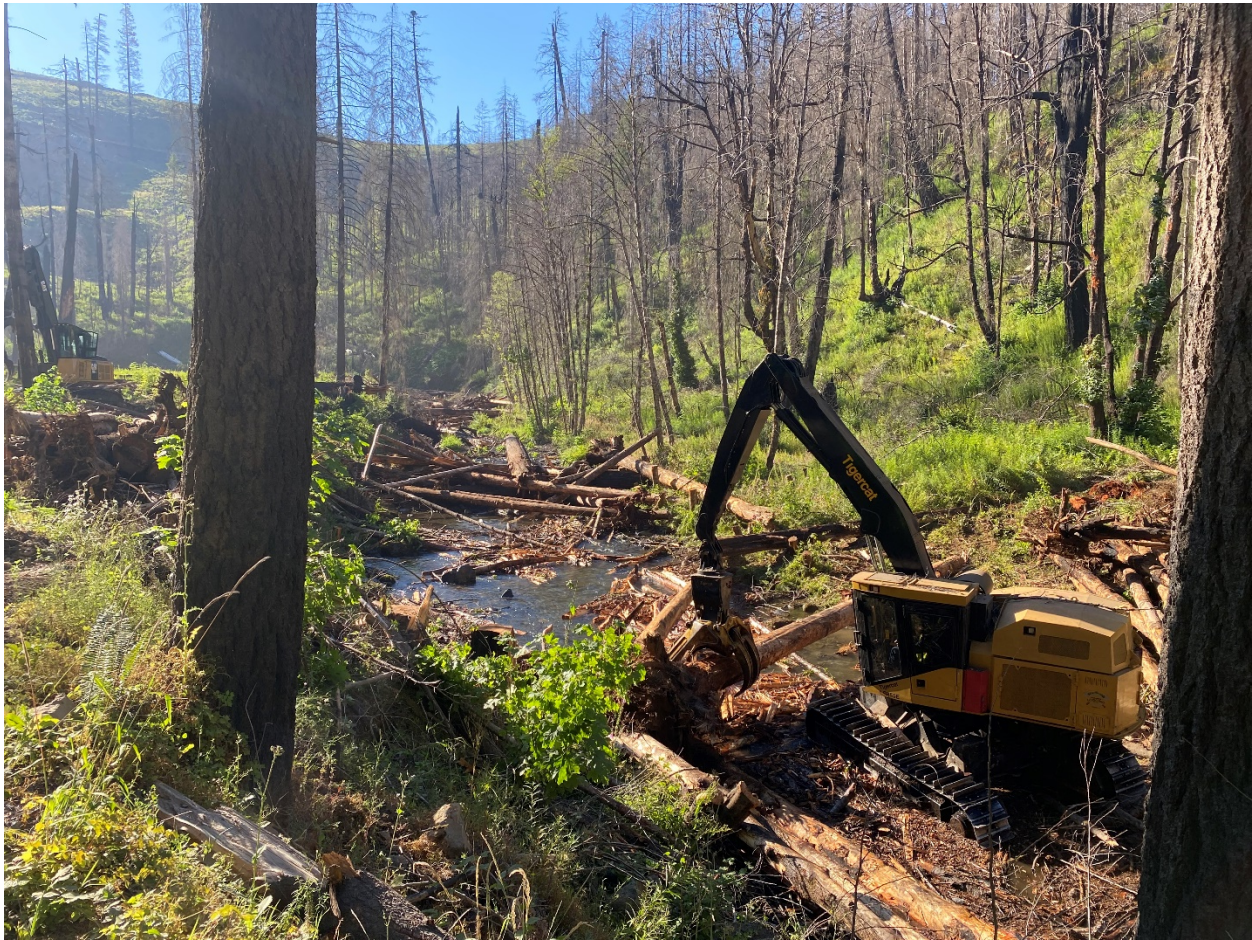
**Figure 1-2: Gate Creek Large Wood Placement**

We continue to work with The McKenzie Watershed Council (MWC), the McKenzie River Trust (MRT), and the U.S. Forest Service (USFS) to implement two different types of large-scale restoration projects. In 2022, we worked on large-scale wood placement at Gate Creek and floodplain restoration in Deer Creek. We also continued project design for Finn Rock Phase II and Quartz Creek. These types of restoration have numerous benefits including, mitigating floods, turbidity, and organic carbon by spreading out and attenuating flows, dropping out sediment, increasing the uptake of nutrients and organic carbon coming from upstream severely burned landscapes, water storage, increasing habitat for fish and wildlife, protection from fire, and increasing cold water refugia.

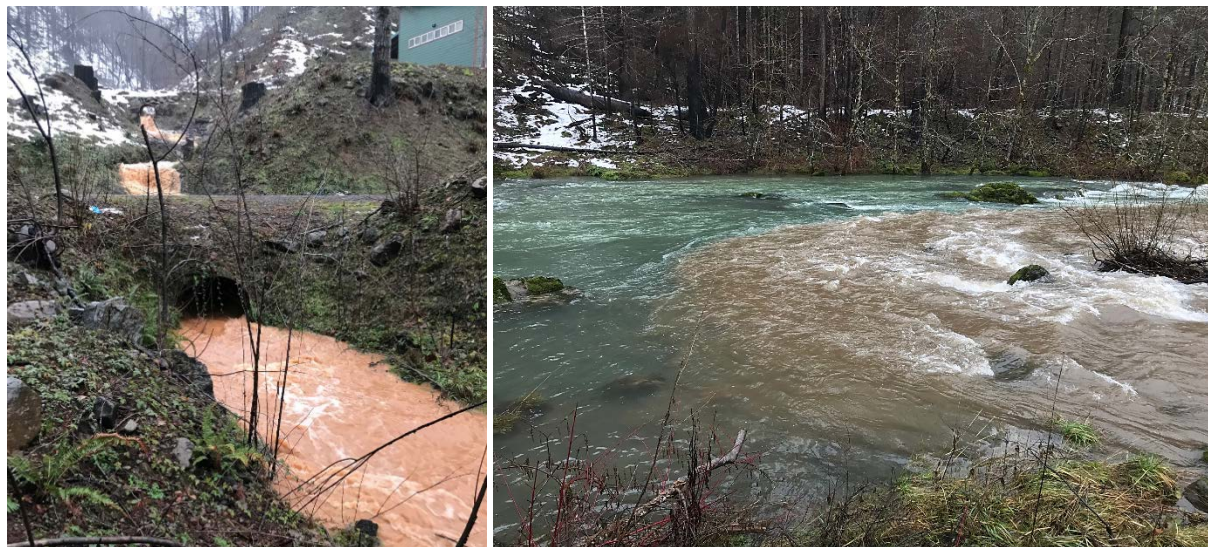
**Figure 3-4: Fern Creek (1/5/22) and Simmonds Creek (1/6/22) entering Blue River during a Storm.**

Most peak dissolved metal concentrations were also typically associated with high flow conditions in urban and HFF locations. However, dissolved manganese, strontium, thallium, and vanadium were reported at or near peak concentrations during baseline conditions, suggesting these metals have stronger ties to groundwater sources. Similar to 2021 results, the highest dissolved metal concentrations were primarily located in the middle to lower watershed, although dissolved vanadium levels were highest in the upper watershed, likely due to the close proximity of young volcanic rock.

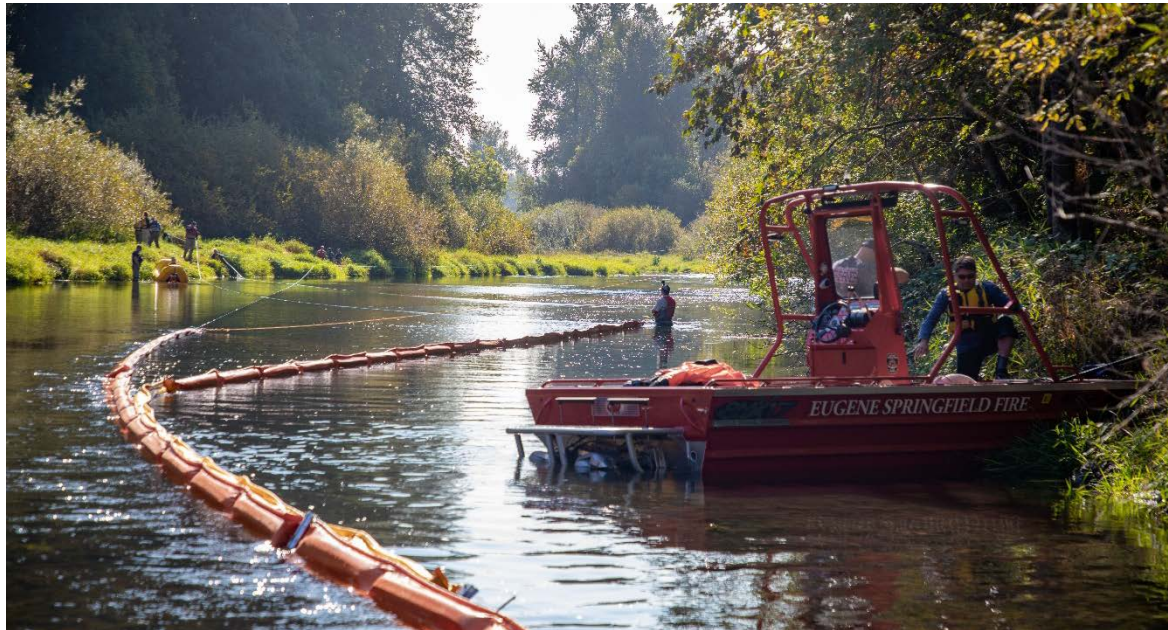
**Figure 4-1: Boom Deployment Drill, Willamette River at Whiteley Landing County Park, 2022**

EWEB worked with multiple partners to coordinate a multi-agency spill response drill on the Willamette River this past fall (see Figure 4-1). Equipment from the McKenzie Watershed Emergency Response System (MWERS) was used to deploy boom across a segment of the Willamette River downstream of

Eugene. The drill gives first responders an opportunity to familiarize themselves with equipment and to test out new response strategies. Several MWERS partners are interested in deploying boom in the Willamette River since they would likely respond to actual spills anywhere in the Upper Willamette River Basin.

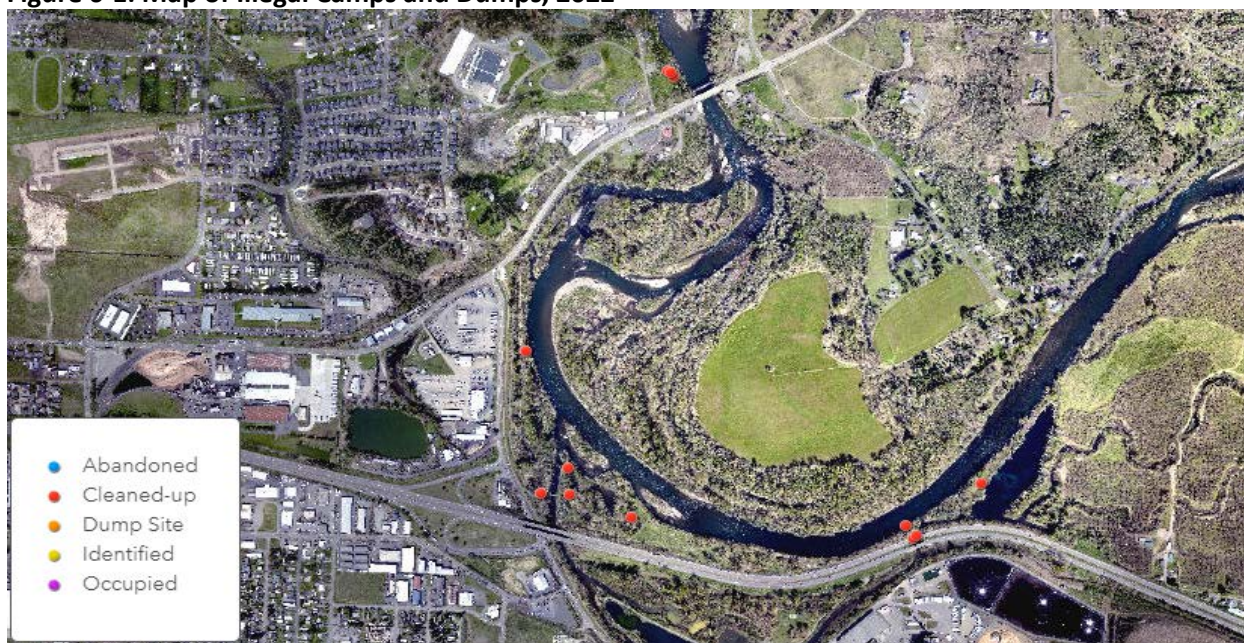
**Figure 6-1: Map of Illegal Camps and Dumps, 2022**

EWEB's Source Protection staff continue to partner with Willamalane Parks, City of Springfield, and Lane County to reduce the impacts of illegal camping and dumping in riparian areas along the McKenzie River immediately above EWEB's intake. Figure 6-1 shows the locations of illegal camps that were cleaned up in 2022. Figure 6-2 illustrates the downward trend of large, well established illegal camps due to the coordinated efforts of these agencies and use of the illegal camping application that identifies camps early and notifies agencies of a camp's existence.
