2025

State of the McKenzie Watershed Report

Eugene Water & Electric Board

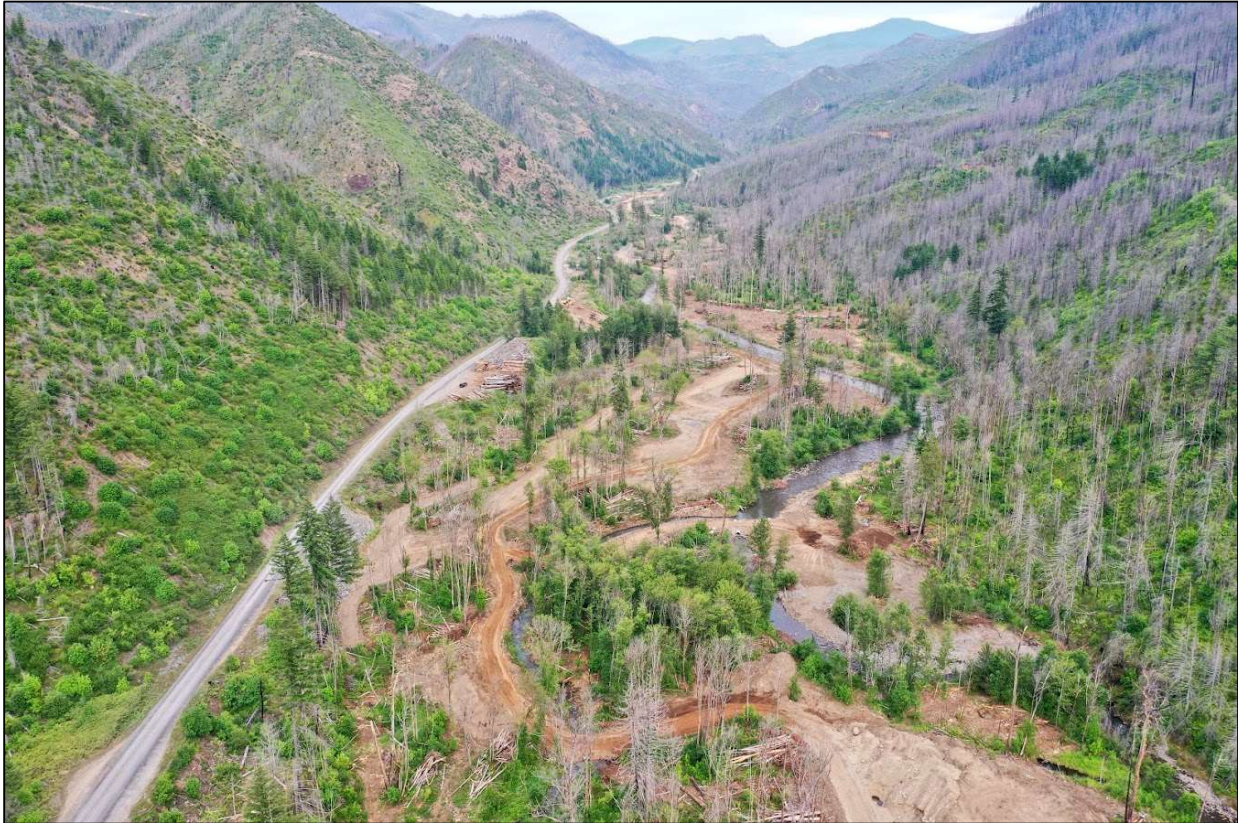
Figure 1-2: Quartz Creek Implementation 2025.

EWEB continues to work with the McKenzie Watershed Council (MWC), the McKenzie River Trust (MRT), and the U.S. Forest Service (USFS) to implement large-scale restoration projects. In 2025, partners successfully completed the large implementation of Quartz Creek (see Figure 1-2.) Partners are currently securing contracts to complete the large flood plain restoration on the South Fork McKenzie in the summer of 2026. These projects are enhancing and improving the McKenzie River watershed and have

been strategically planned to tie into each other for numerous benefits including mitigating floods, turbidity, and organic carbon by spreading out and attenuating flows, dropping out sediment, increasing the uptake of nutrients and organic carbon from upstream severely burned landscapes, storing water, increasing habitat for fish and wildlife, increasing resiliency to wildfire, and increasing cold water refugia.

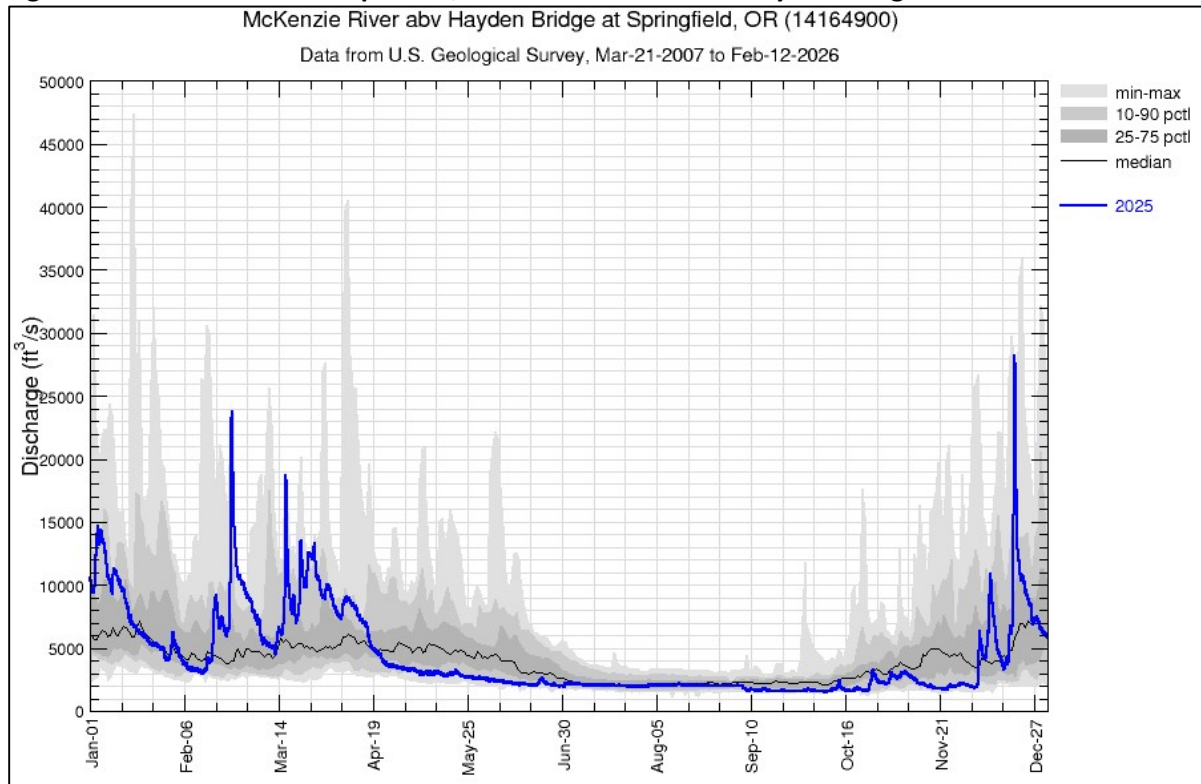
Figure 2-1: Historic Flow Comparison, McKenzie River above Hayden Bridge

23,600 cfs. However, flows dropped below median levels by mid-spring, and with few exceptions, remained below median values until the first week of December. Additionally, flows during the months of May, June, September, October and November were consistently below the 25th percentile, with numerous instances of flows dropping below the 10th percentile. Heading into December, flows dropped to a low of 1,840 cfs on December 3rd, but a series of atmospheric river events shortly after pushed flows near or above median values through the remainder of the year, which included the highest observed flow of the year on December 19th, when flows reached 28,200 cfs at Hayden Bridge (provisional USGS data). The lowest flow of the year at Hayden Bridge occurred on October 7th and 8th, when observed flow dropped to 1,510 cfs (below the 10th percentile).

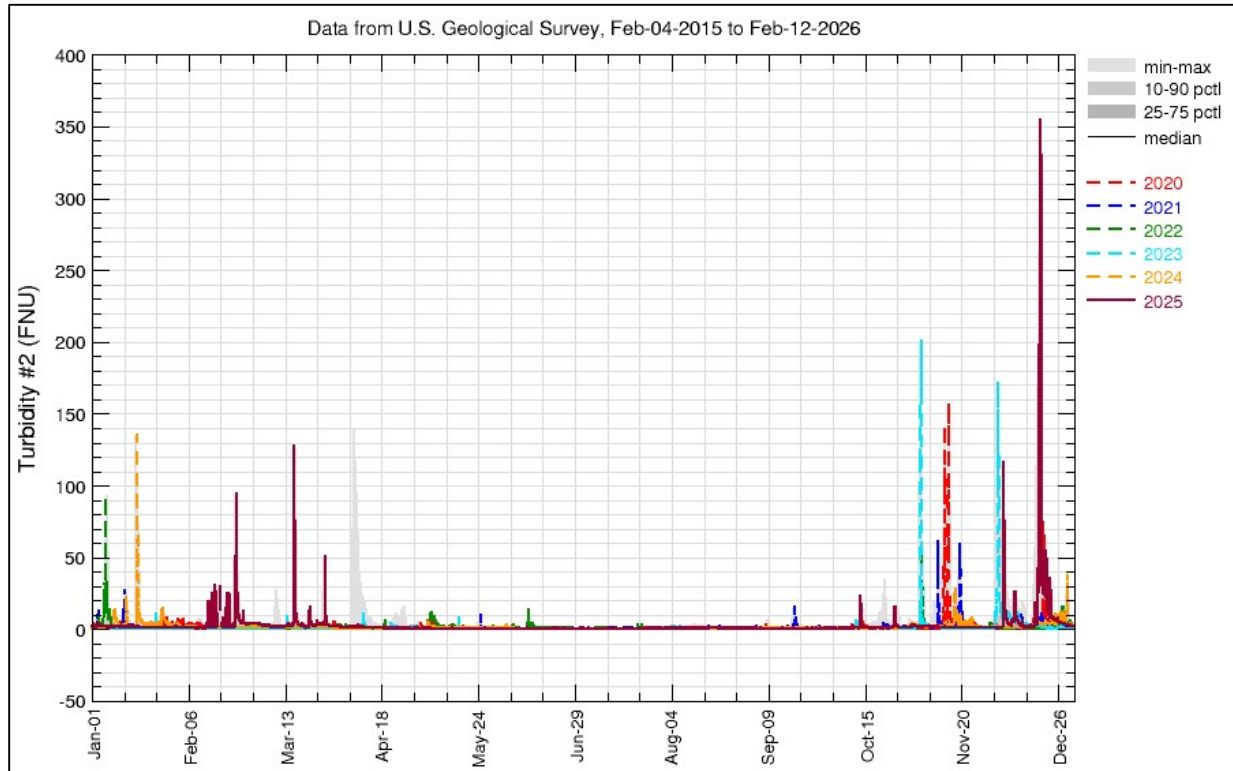
Figure 3-1: Major Turbidity Event Comparison, McKenzie River near Vida, 2020-2025*

As illustrated below in Figure 3-1 by the solid burgundy line, turbidity levels (measured in Formazin Nephelometric Units or FNU) in the McKenzie River near Vida peaked in 2025 during storm events on February 23rd (>50 FNU), March 16th (>100 FNU), March 27th (<50 FNU), December 5th (>100 FNU) and again on December 19th (>200 FNU). In contrast, turbidity levels between runoff events at the same site in 2025 were less than 2 FNU around 80% of the time and less than 1 FNU just over 50% of the time. With at least 4 mainstem McKenzie River turbidity events exceeding 50 FNU, the trend of at least two 50 FNU turbidity events per year in the mainstem McKenzie River post-Holiday Farm Fire continues. In comparison, between 2015 and 2019, there were only two mainstem events that exceeded 50 FNU.

*2025 USGS data was considered preliminary when the chart was created.

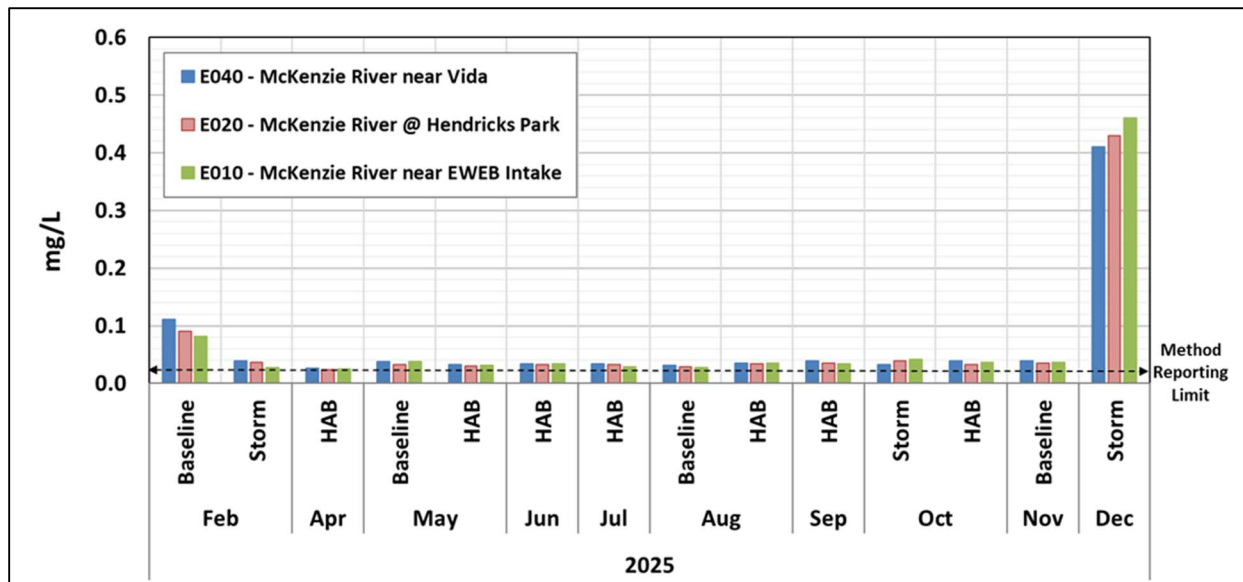
Figure 3-6: Maximum Monthly Orthophosphate Concentrations at Select Mainstem McKenzie Sites

Total phosphorus concentrations observed in 2025 across most sites over 3 quarterly baseline events fell below 0.05 mg/L, while several urban-related sites climbed slightly higher, but did not exceed 0.07 mg/L (minimum RL was 0.02 mg/L), which is typical. Total phosphorus results for the February baseline event were not available due to lab complications. However, results for orthophosphate, which is the inorganic form of phosphorus that is readily available for algae and plant uptake, were available for the February event and showed elevated levels across most sites. In fact, the median orthophosphate value for the February event was 0.094 mg/L, which was more than double the median value for the remaining 2025 quarterly events (0.032 mg/L). Significant precipitation events around the start of the year, followed by a lack of rain heading into February and a potential shift to higher groundwater discharge ratios, coupled with little primary production, may have contributed to the elevated orthophosphate levels observed in mid-February. Results from additional nutrient samples collected during seasonal HAB events between April and October were similar to previous years, with almost all total phosphorus results staying below 0.05 mg/L. The one exception was a sample collected from Blue River on June 30th that coincided with a brief flow increase out of Blue River Reservoir that mobilized benthic algae and sediment, yielding a total phosphorus concentration of 0.358 mg/L. All HAB-related orthophosphate results stayed at or below 0.04 mg/L. With respect to 2025 storm event monitoring efforts, total phosphorus and orthophosphate results observed during mid-December high flow events were significantly higher than results for similar HFF sites in February (max 0.42 and 0.043, respectively), as well as for urban stormwater sites in October (max 0.21 and 0.137, respectively), effectively contributing to overall higher mainstem McKenzie concentrations in December (see Figure 3-6).

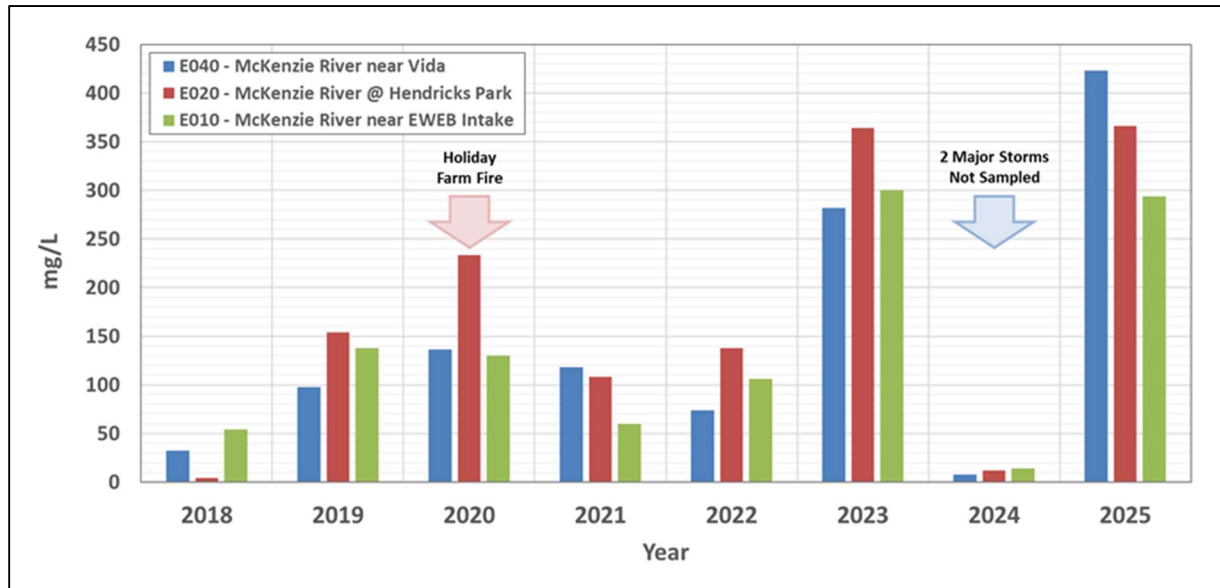
Figure 3-8: Maximum Total Suspended Solids (TSS) at Select McKenzie Sites by Year (2018-2025).

While gravel and sediment movement through riverine systems can be beneficial for aquatic organisms, excessive solids can also carry contaminants and pathogens through the watershed, impacting ecosystem function as well as being a concern for drinking water treatment, particularly around filtration processes. Baseline results for total suspended solids (TSS) and total dissolved solids (TDS) were largely typical across most sites during 2025, with baseline median values at 1 mg/L for TSS and 41 mg/L for TDS. The highest observed baseline TSS (12 mg/L) and TDS (140 mg/L) results were both attributed to the 52nd SWC.

With respect to storm sampling results, TDS values were generally unremarkable, except for Quartz Creek, where TDS reached 54 mg/L at the upper site and 104 mg/L at the lower site during a strong atmospheric river event in December. This event generated exceptionally high flow conditions and active channel scouring within the recently reconnected Quartz Creek floodplain restoration area (located between the upper and lower monitoring sites). Consequently, lower Quartz Creek recorded the highest TSS value (2,050 mg/L) observed by Source Protection staff in the McKenzie Watershed over the past 20 years. During the same event, TSS at the upper Quartz Creek site was measured at 359 mg/L, while Gate Creek reached 540 mg/L as flows surpassed 4,000 cfs in the tributary (USGS preliminary readings). The resulting impact to the mainstem McKenzie was most pronounced near Vida, where TSS was measured at 423 mg/L, which is the highest observed mainstem McKenzie TSS value observed by Source Protection staff over the past 20 years (see Figure 3-7). Although high, TSS values proceeded to decrease moving downstream in the McKenzie River at Hendricks Park (366 mg/L) and then near Hayden Bridge (294 mg/L), likely due to lower sediment levels in downstream tributaries and some settling within lower velocity sections of the river.

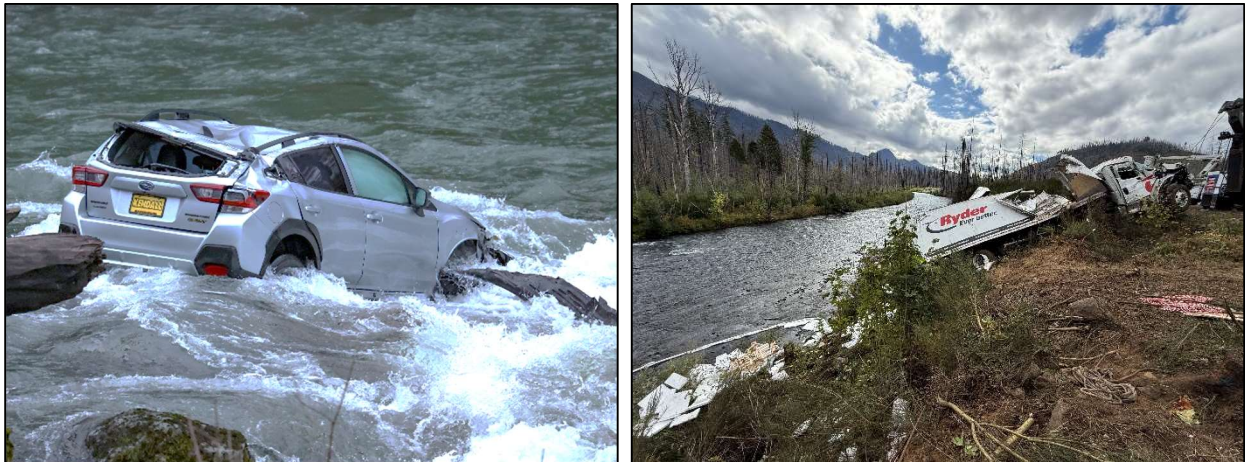
Figure 4-1: Vehicle Crashes Reaching the McKenzie River, 2025.

There were seven reported incidents in the McKenzie Watershed in 2025 that EWEB Source Protection staff tracked for potential water quality contamination in the McKenzie River (see Table 4-1). Several of the incidents involved serious vehicle accidents resulting in injuries, but with minimal or no observed hydrocarbon release to the river. One event, which resulted in a car entering the McKenzie River and floating downstream before getting stranded in a rapid, required a U.S. Coast Guard helicopter to rescue the driver (see Figure 4-1, left image). Thanks to a coordinated effort, including flow reductions to the mainstem McKenzie by the U.S. Army Corps of Engineers, swift water crews were able to attach a tow rigging and the vehicle was successfully removed from the river. Another accident that occurred above Blue River involved a large box truck that left the roadway and rolled down a steep bank, coming to rest partially in the river. Although some very localized sheen was observed in the McKenzie River along the bank immediately downstream of the accident, most of the released diesel and engine oil from the truck occurred up the bank in soil. Once the truck was removed, the contaminated soil was tarped and eventually excavated and replaced by a spill response contractor (see Figure 4-1, right image).

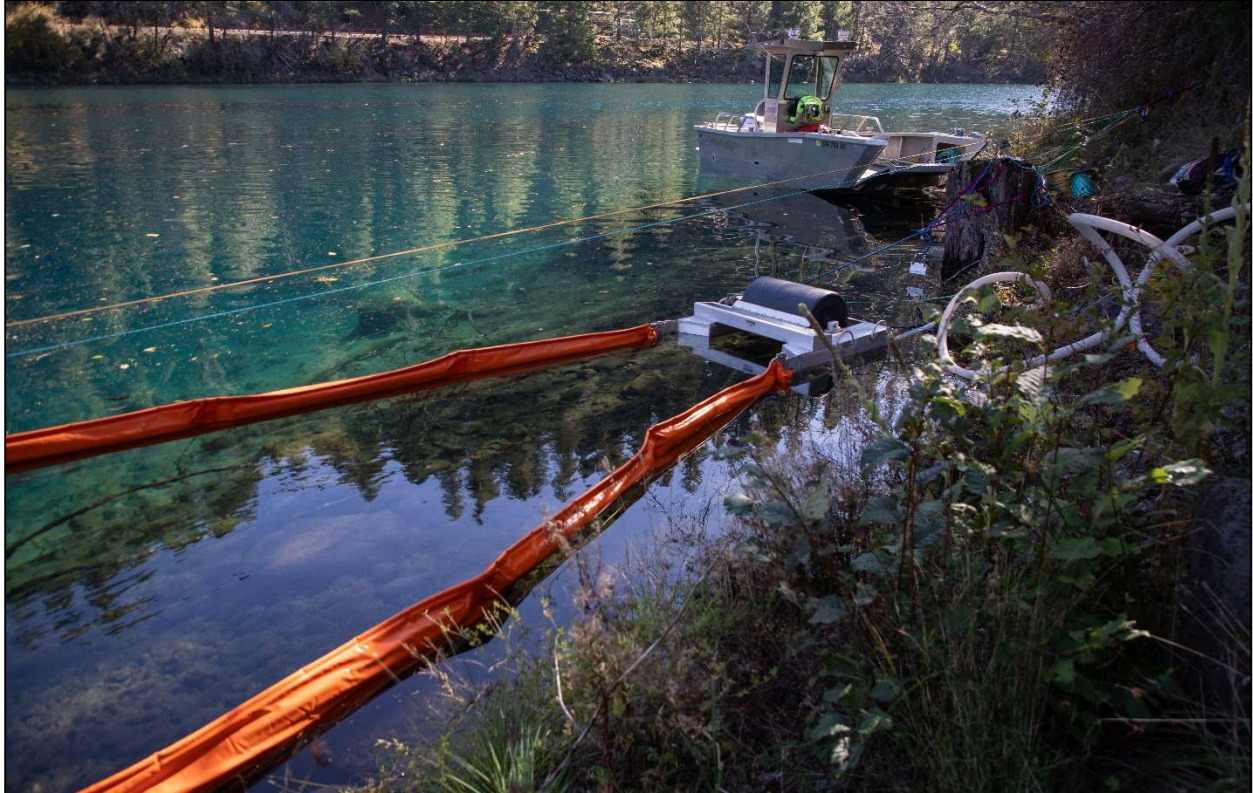
Figure 4-2: MWERS Spill Response Drill, McKenzie River at Trail Bridge Reservoir, 2025

EWEB worked with multiple partners to coordinate another successful multi-agency spill response drill on the McKenzie River this past fall at Trail Bridge Reservoir (see Figure 4-2), which is the third visit to this site over the past 15 years. A special thanks to EWEB’s Generation staff and the USFS for allowing access to the area for the spill drill during the closure period. The 2025 spill drill involved around 45 participants and observers, representing a dozen different agencies or organizations, including staff from the cities of Medford, Salem and Hillsboro. Equipment from the McKenzie Watershed Emergency Response System (MWERS) was used to deploy boom across the McKenzie River just below the Carmen-Smith Power Plant. The drill gives first responders an opportunity to familiarize themselves with equipment, build relationships, strengthen communication lines, and to test strategies that could be implemented in the event of an actual spill. The Trail Bridge Reservoir site represents one of the highest MWERS response strategies in the McKenzie Watershed with good access on both sides of the river.

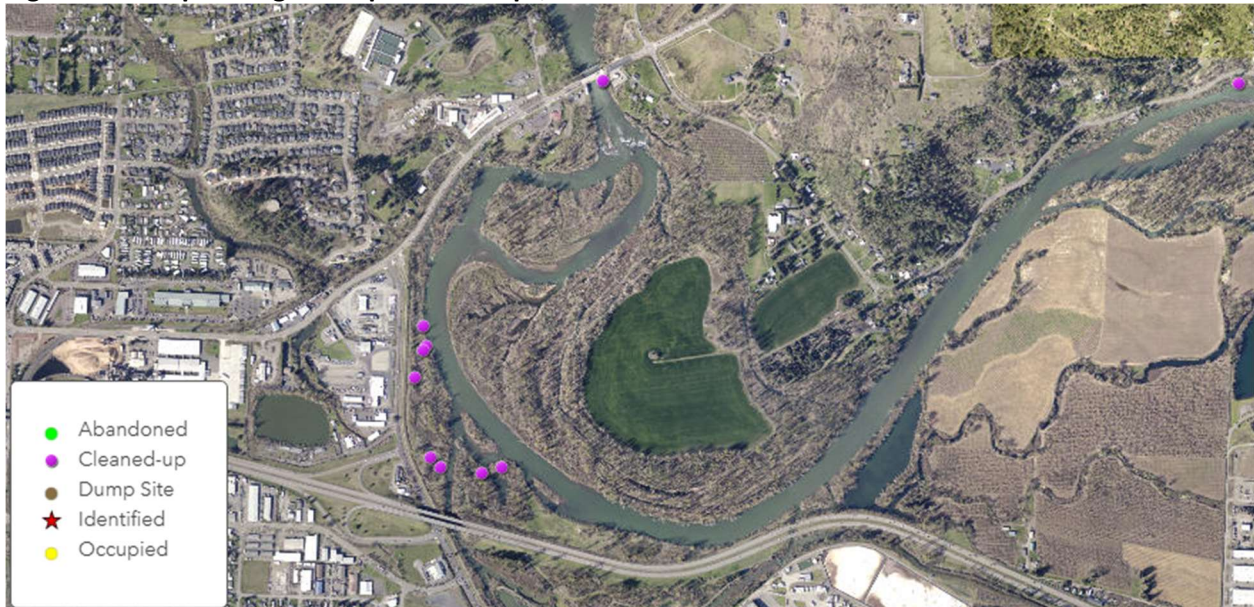
Figure 6-1: Map of Illegal Camps and Dumps, 2025

above EWEB’s intake. Figure 6-1 shows the locations of illegal camps and dumping that were cleaned up in 2025. Figure 6-2 illustrates the low occurrence of large, well established illegal camps due to the coordinated efforts of these agencies and use of the illegal camping application that identifies camps early and notifies agencies of a camp’s existence.

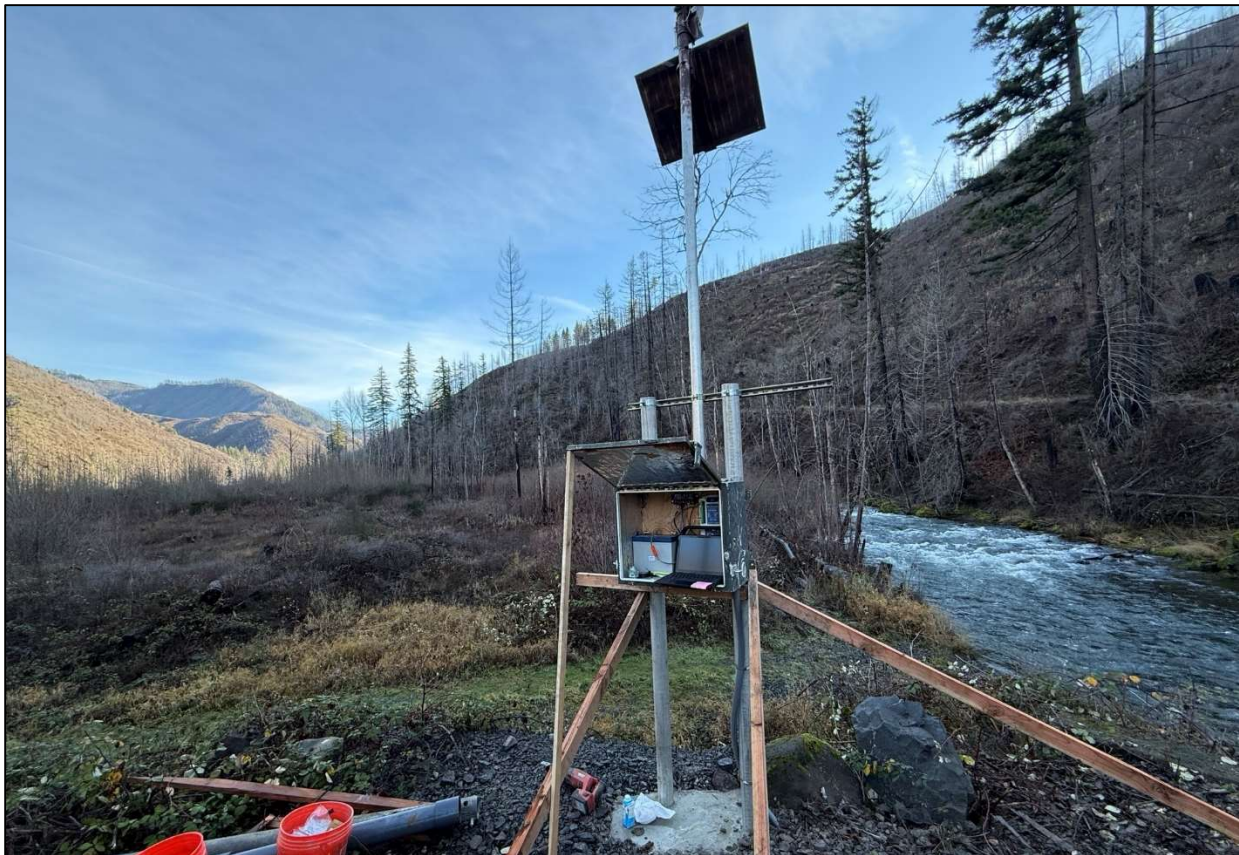
Figure 11-1: Installing New Upper Quartz Creek Water Quality Monitoring Station (USGS/EWEB)

The continuous discharge and water quality monitoring network managed by the USGS and co-funded through EWEB's Source Protection and Generation programs continues to be an integral part of providing Hayden Bridge and Generation staff with timely and critical real-time information for the McKenzie River system. This network becomes exceptionally valuable during rapidly changing conditions, such as during prolonged rain events or sudden operational changes at hydroelectric facilities or dams. The USGS maintains 8 water quality monitoring stations on behalf of EWEB, along with 12 discharge monitoring stations. The USGS maintains 9 additional discharge monitoring stations within the McKenzie Watershed with other partners. EWEB Source Protection staff complement the McKenzie network with 7 additional continuous water quality sites, 4 of which are set up with telemetry to communicate results. Real-time data from these stations is currently available to staff through the McKenzie River Information System (MRIS) and Aquarius, which is a cloud-based data management system for storing, managing and disseminating Source Protection's continuous water quality monitoring data. Staff continued to build capabilities and integrate additional data resources into the Aquarius platform during 2025, including historical data.
