Consulting Structural Engineers Portland, Oregon • Tacoma, Washington

Re: College Hill 607 Reservoir Evaluation

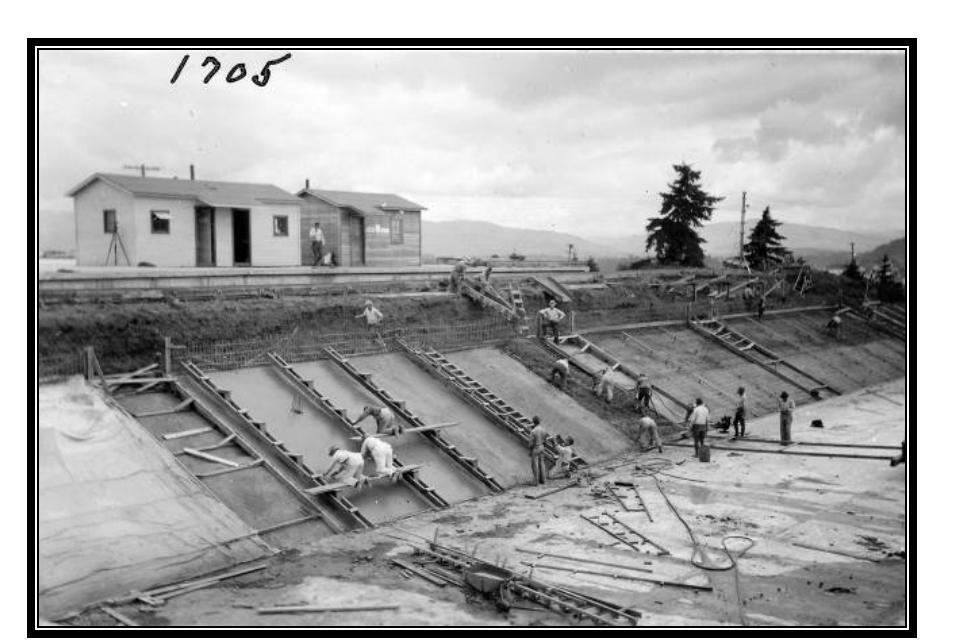
Figure 1: College Hill 607 Reservoir During Construction (Photo Credit: EWEB)

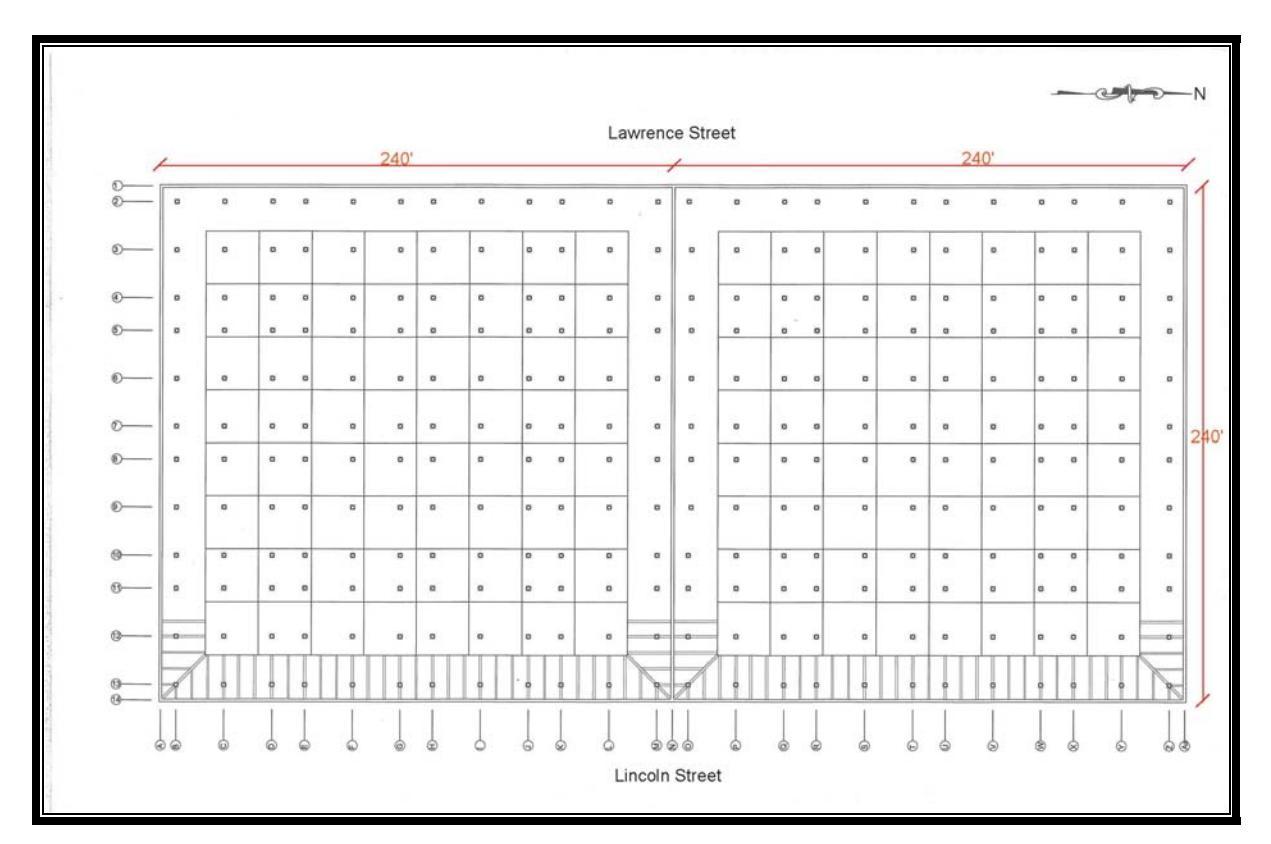
For most of the perimeter of the tanks the sloped floor slabs are constructed on grade. However, for the entire eastern edge and short end returns of the north and south edges of both tanks, the sloped floor slabs are supported by a series of 8" and 12" thick bearing walls. Appendix Figure 2 shows the extent and location of these support walls. Open space exists between these walls and there is a hallway that allows access underneath these portions of the sloped floor slabs. Appendix Figure 3 is a reproduction of an original construction drawing showing a section through the eastern edge of the tanks including this hallway.

Figure 2: Floor Plan Showing Both Tanks and Extent of Walls Supporting the Sloped Floor Slab Along Eastern Edge and Portions Each Tank's North and South Edges

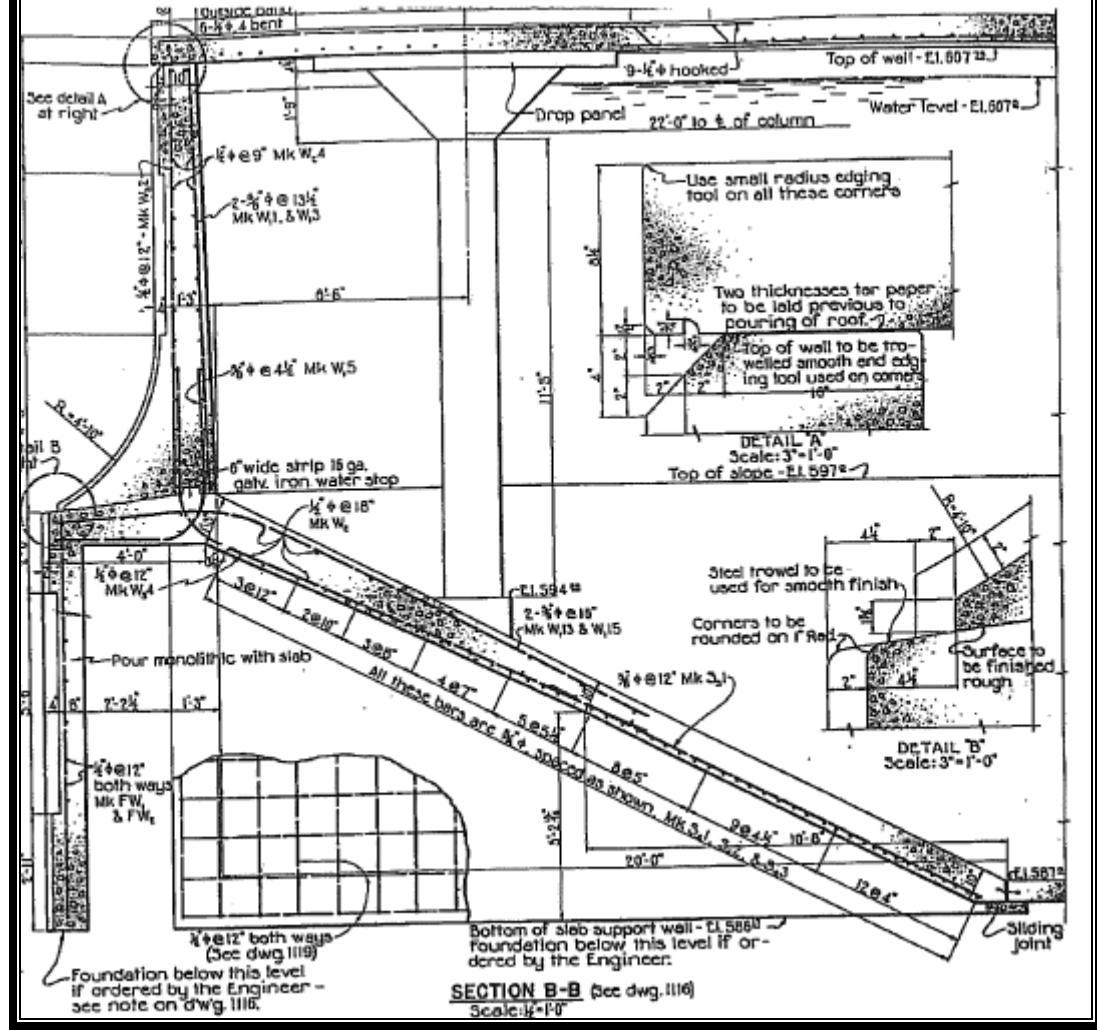
Figure 3: Original Construction Drawing Showing Section Through the Sloped Floor Slab, Bearing Wall, and Hallway Underneath the Eastern Side of the Tanks
